1. Report No.	2. Government Accession No.	3. Recipient's Catalog No.	
4. Title and Subtitle NCHRP REPORT 350 TESTING OF THE ET-PLUS FOR 31-INCH-HIGH W-BEAM GUARDRAIL		5. Report Date July 2005	6. Performing Organization Code

7. Author(s) C. Eugene Buth, Dean C. Alberson, Roger P. Bligh, and D. Lance Bullard, Jr.		8. Performing Organization Report No. 220601-1&2	
9. Performing Organization Name and Address Texas Transportation Institute The Texas A&M University System College Station, Texas 77843-3135		10. Work Unit No. (TRAIS)	11. Contract or Grant No. 220601

12. Sponsoring Agency Name and Address Trinity Industries, Inc. 2525 Stemmons Freeway Dallas, TX 75207		13. Type of Report and Period Covered Test Report: April 2005 – June 2005

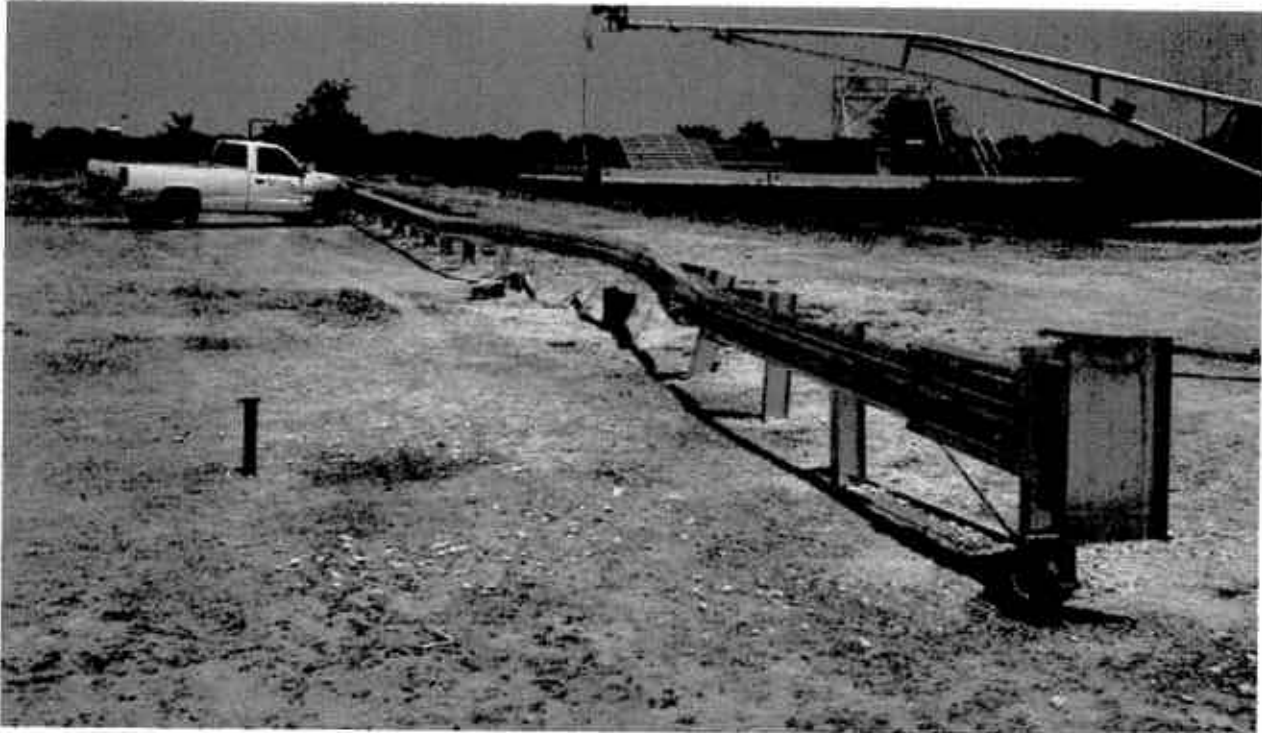
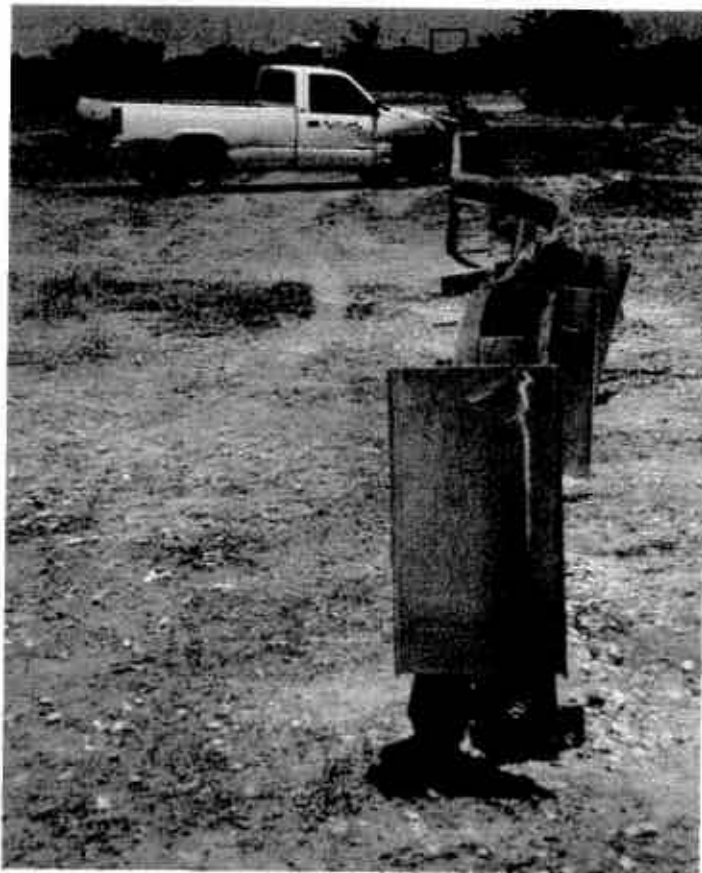
Figure 11. Vehicle trajectory path after test 220601-1.

The ET-PLUS for 787 mm (31-inch) high W-beam guardrail contained and redirected the pickup truck with a maximum dynamic rail deflection of 939 mm. One breakout split, and a portion separated from post 6 and came to rest next to post 7. However, the split breakout did not penetrate nor show potential for penetrating the occupant compartment, nor to present undue hazard to others in the area. No measurable occupant compartment deformation occurred. The pickup truck remained upright during and after the collision event. The pickup truck did not intrude into adjacent traffic lanes. As the vehicle lost contact with the rail, it yawed clockwise and came to rest adjacent to the rail. Occupant risk factors were within the required limits. Exit angle at loss of contact was not attainable; however, the vehicle was yawing clockwise (toward the rail) as it lost contact.

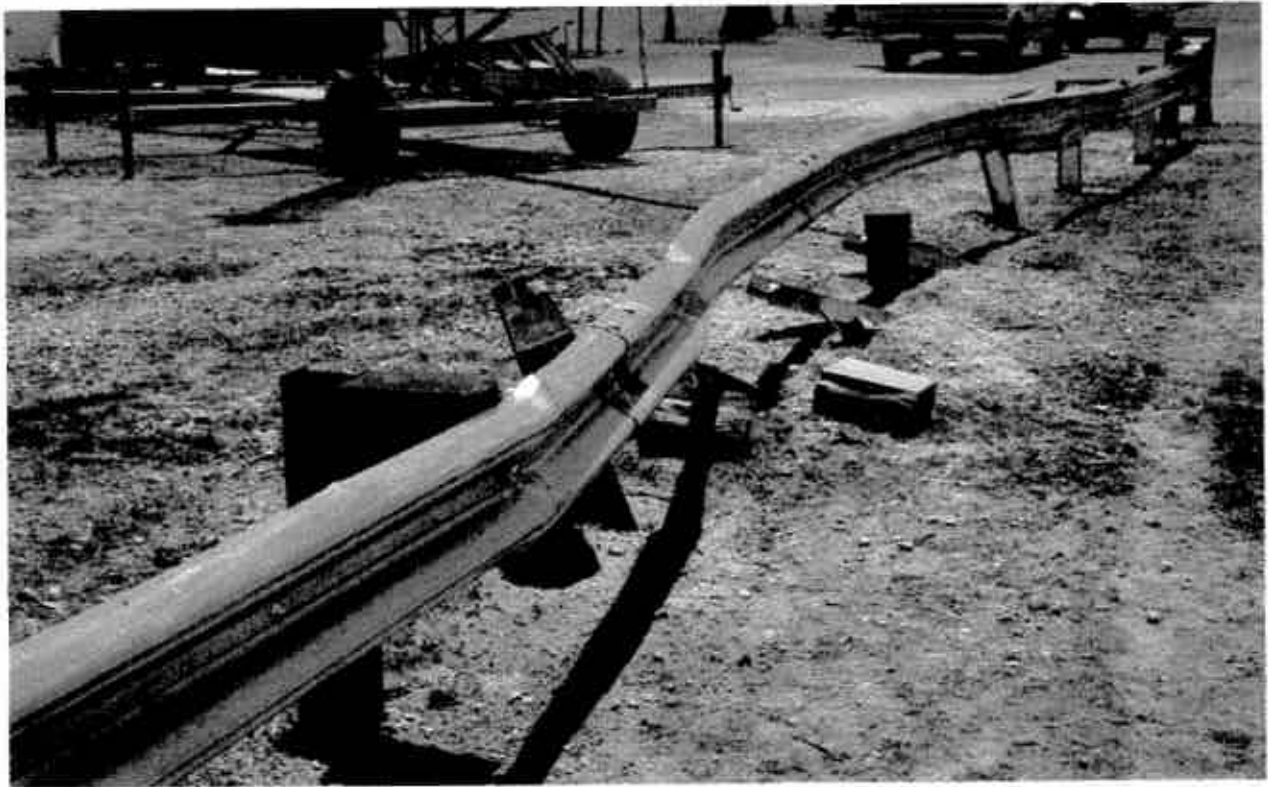
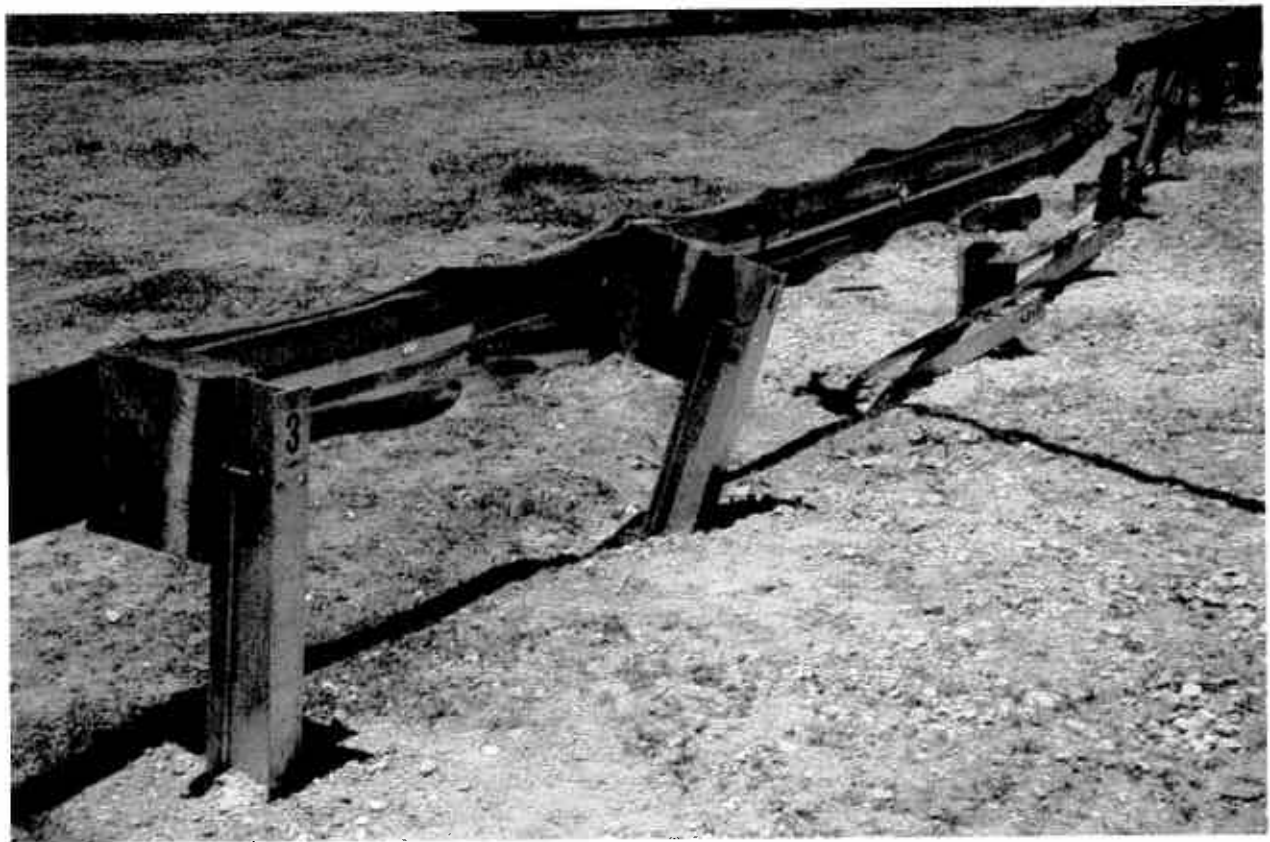
Figure 12. Installation after test 220601-1.

Damage to the installation is shown in figures 11 and 12. The anchor base around post 1 moved downstream 70 mm, and post 1 was leaning toward the field side 19 mm. Post 2 was only disturbed, post 3 was pushed toward the field side 30 mm, and post 4 was pushed toward the field side 155 mm. The rail was separated from posts 5 through 9. Post 5 was pushed toward the field side 100 mm and the blockout was barely attached to the post. Post 6 was pushed toward the field side 51 mm, and the blockout was split with the biggest portion resting at post 7. Post 7 was pushed toward field side 51 mm and the blockout was barely attached to the post. Post 8 was pushed toward field side 92 mm and the blockout and side of the post were marred from contact with the vehicle. Post 9 was pushed toward field side 20 mm, and the blockout was slightly loose. The vehicle then contacted the rail again at post 15, and came to rest between posts 15 and 16. Total length of contact of the vehicle during the initial contact with the rail was 7.6 m. Maximum dynamic deflection of the rail during the test was 939 mm, and maximum residual deformation was 255 mm.

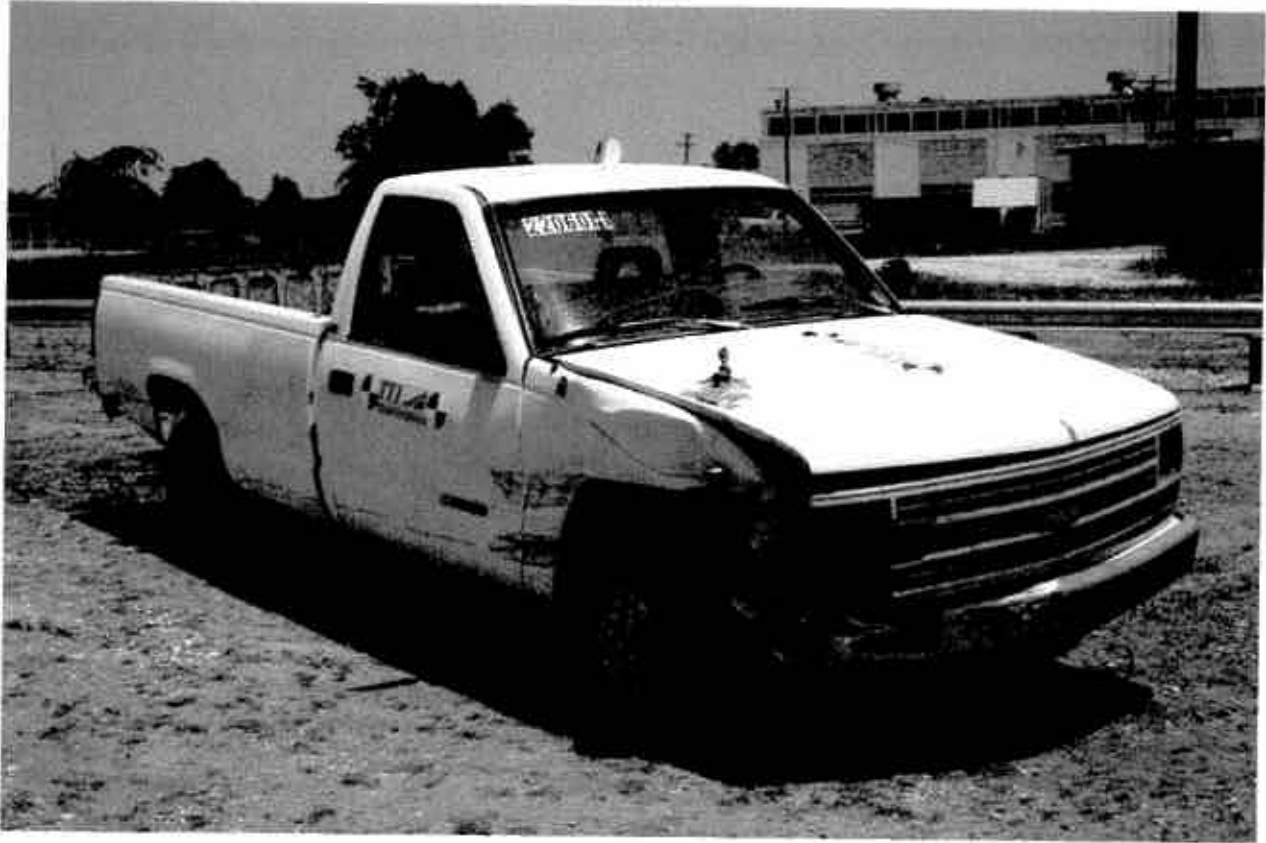
Figure 13. Vehicle after test 220601-1.

The vehicle sustained damage to the right side, as shown in figure 13. Structural damage included a broken right outer tie rod end and deformed right frame rail. Other damage included the front bumper, hood, grill, radiator, fan, right front quarter panel, right door, right rear exterior bed, and the rear bumper. Both wheel rims on the right side were deformed and the tires deflated. Maximum exterior crush to the vehicle was 530 mm in the right side plane at the right front corner at bumper height. No measurable occupant compartment deformation occurred. Photographs of the interior of the vehicle are shown in figure 14. Exterior vehicle crush and occupant compartment measurements are shown in appendix B, tables 3 and 4.

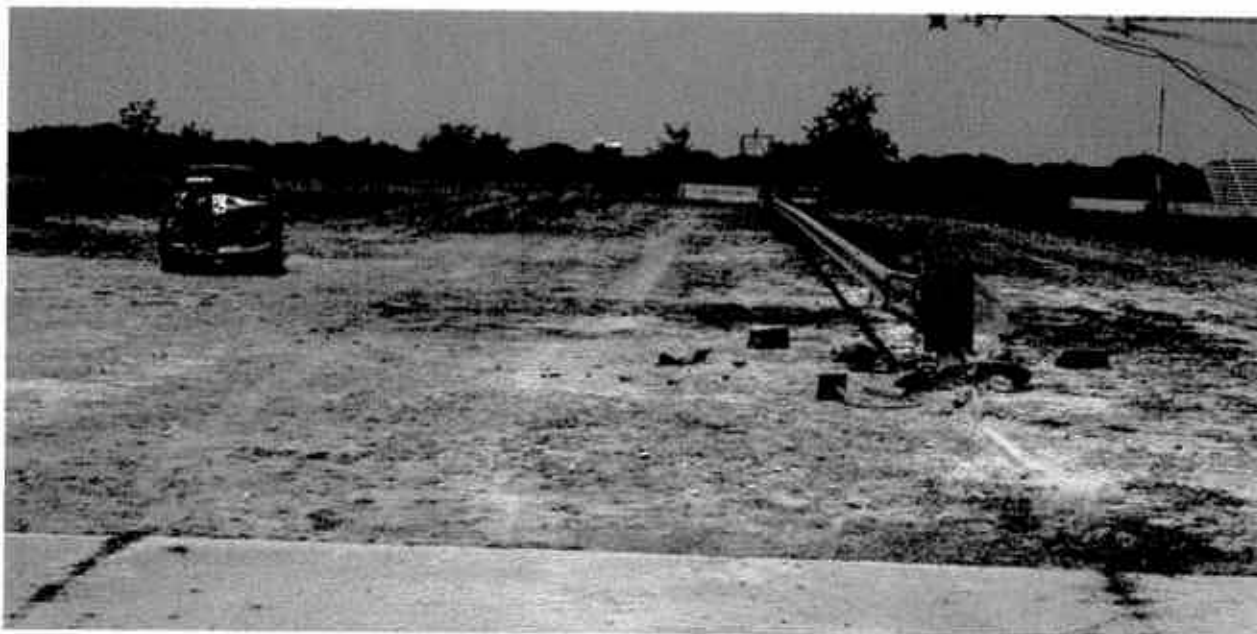
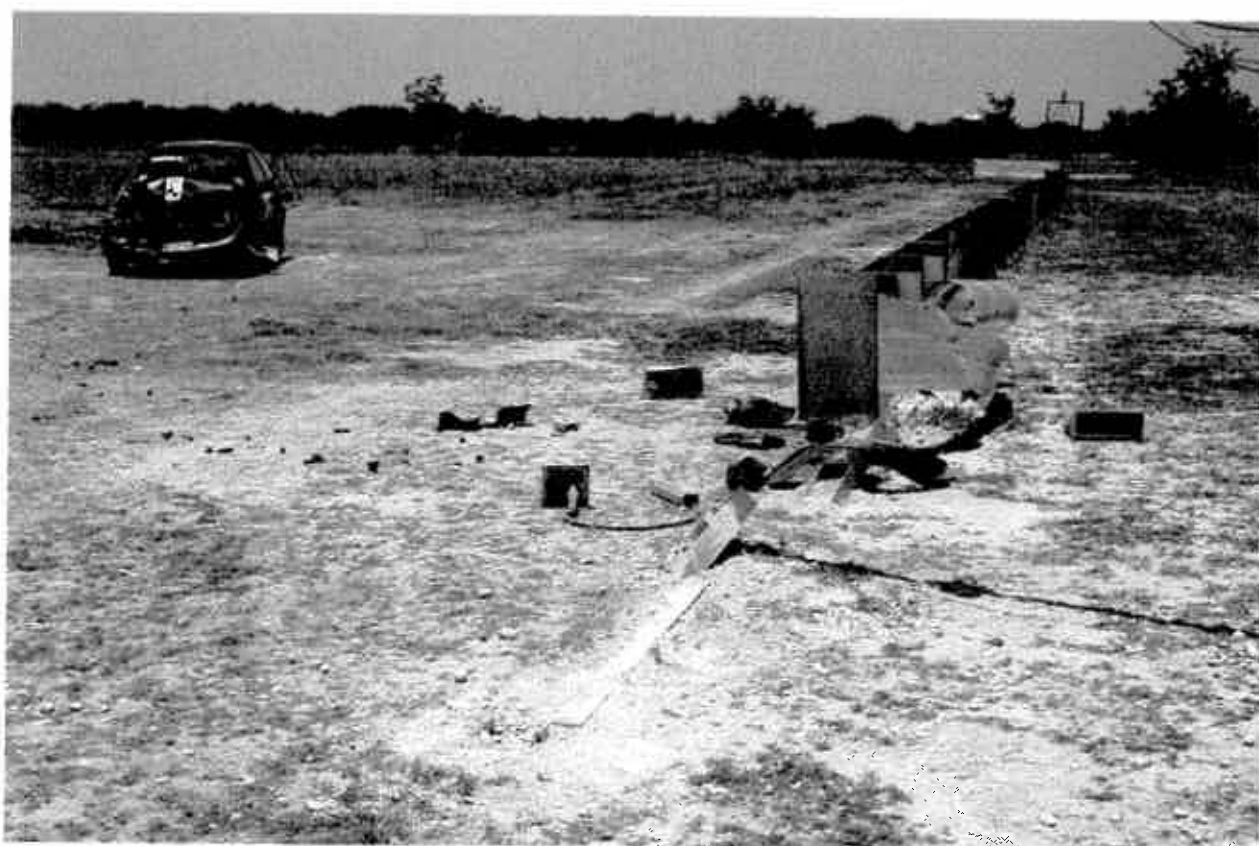
Figure 18. Vehicle trajectory path after test 220601-2.

Result: The small car intruded into traffic lanes 8.5 m. (FAIL)

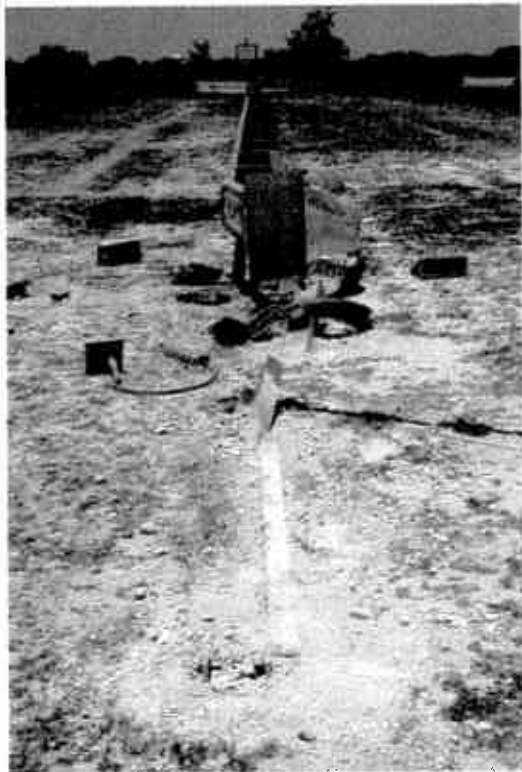
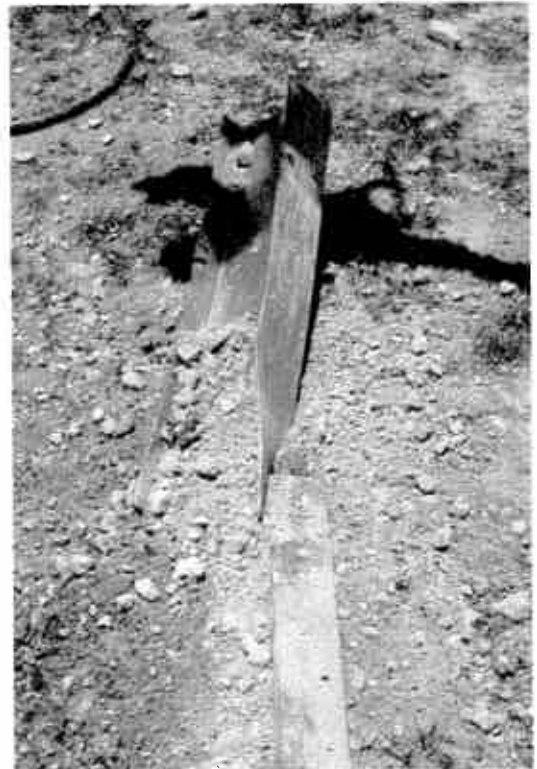
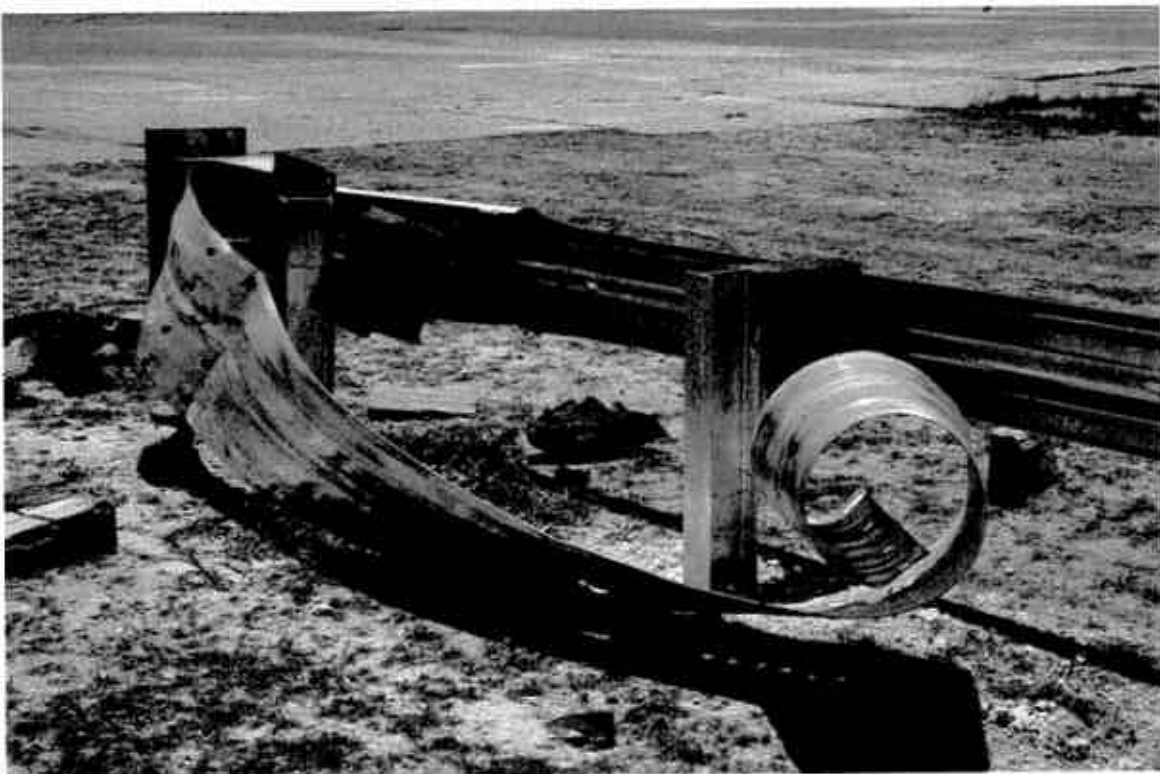
Figure 19. Installation after test 220601-2.

Damage to the installation is shown in figures 18 and 19. Post 1 released with no movement at the base. The top bolt remained attached to the ET head. The anchor assembly came to rest 0.8 m in front of the traffic face of the rail between post 2 and 3. Post 2 was leaning downstream at 85 degrees, and post 3 at 80 degrees. Post 4 was rotated clockwise 45 degrees, the blockout was fractured and the slot in the rail torn. No movement was noted in post 5 and beyond. A total of 5.4 m fed through the ET head.

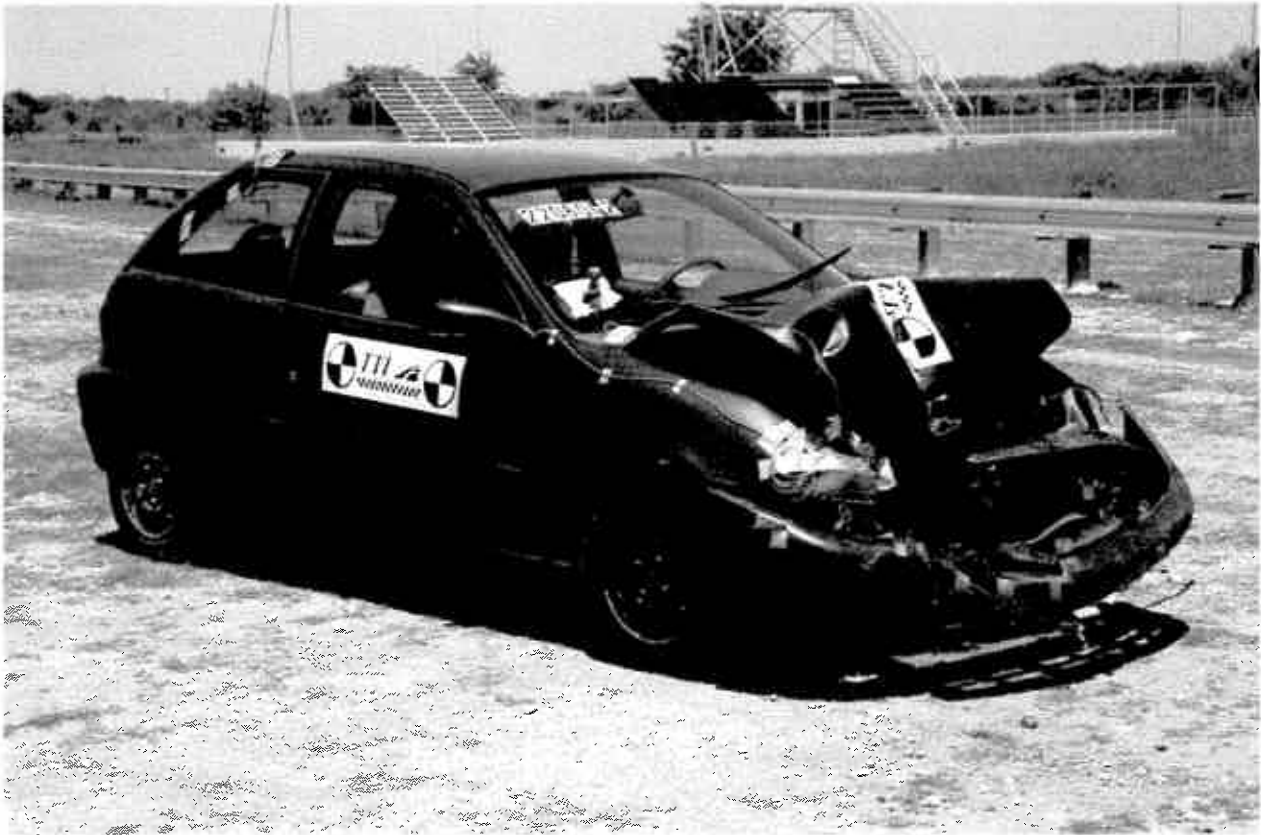
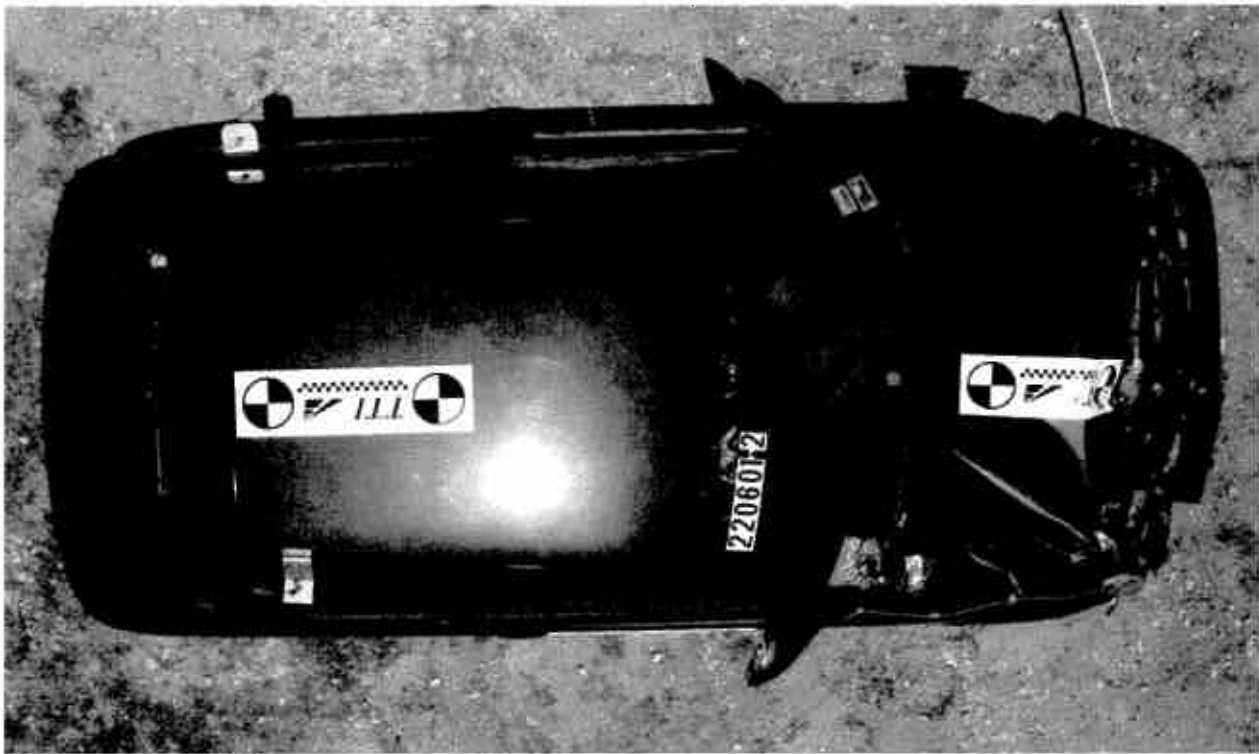
Figure 20. Vehicle after test 220601-2.

The vehicle sustained damage to the front, as shown in figure 20. The only structural damage was a deformed right strut tower. Other damage included deformation of the front bumper, hood, radiator, fan, radiator support, and right and left front quarter panels. The right rear tire was deflated. Maximum exterior crush to the vehicle was 420 mm in the frontal plane at the front right corner just above the bumper. No occupant compartment deformation occurred. Photographs of the interior of the vehicle are shown in figure 21. Exterior vehicle crush and occupant compartment measurements are shown in appendix B, tables 5 and 6.
