TRINITY INDUSTRIES, INC., et. al.,	)	
	)	
Plaintiff,	)	
	)	
v.	)	Civil Action No. 1:11cv937-CMH-TRJ
	)	
SPIG INDUSTRY, LLC, et. al.,	)	
	)	
Defendant.	)

**DECLARATION OF WILLIAM STAMPS HOWARD**

TRINITY012683 Shows a 5-inch ET-PLUS

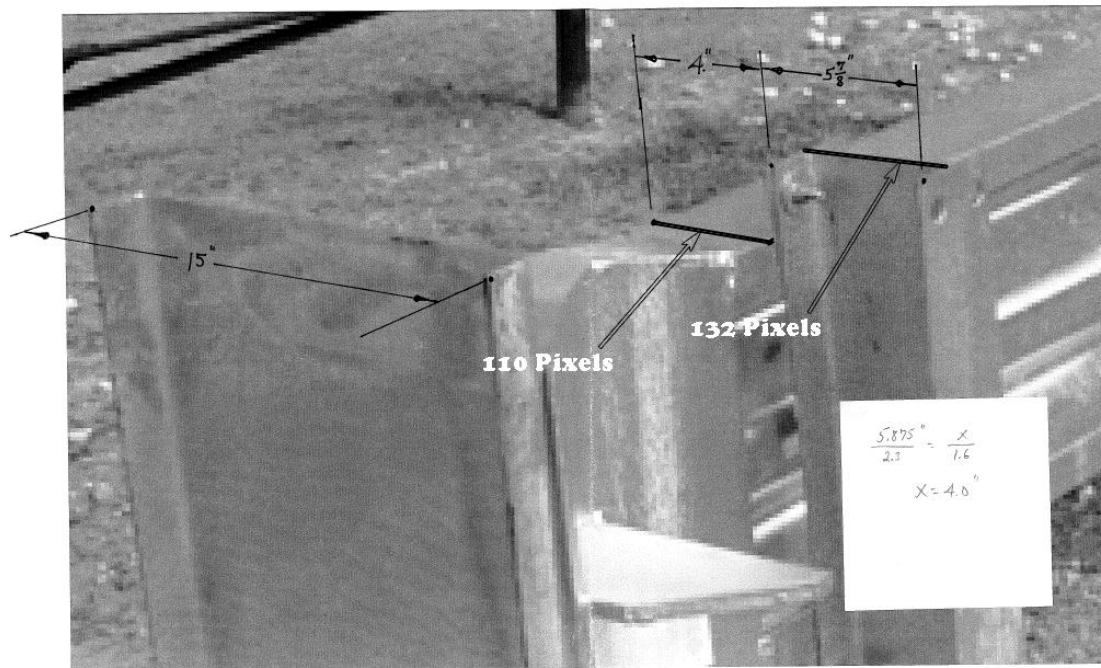
12. In order to measure the size of the rail feeder in TRINITY012683, I took a screen shot of the PDF file. From that, I measured the width of the I-Beam as well as the width of the Rail Feeder Chute. I found the I-Beam to be approximately 132 pixels wide, while the Rail Feeder Chute was approximately 110 pixels wide. Based on the 5.875 inch measurement of the I-Beam, the Rail Feeder Chute is seen to be approximately  $(110/132) * 5.875 = 4.9$  inches wide.

13. I also printed out TRINITY012683, and took measurements of the printed drawing. Using a caliper to obtain precise measurements, and measuring at the center of the I-Beam, I found the I-Beam to be approximately 1.26 inches wide, while the Rail Feeder Chute was 1.04 inches wide. Based on the 5.875 inch measurement of the I-Beam, the Rail Feeder Chute is seen to be approximately  $(1.04/1.26) * 5.875 = 4.85$  inches wide.

14. To the extent that I can discern from the blown-up version of the PDF, the dots marked on TRINITY012683 are slightly off, resulting in a slightly wrong measurement of the I-Beam. However, if I use the dots as marked, and measure the I-Beam at that point, I obtain a measurement of 1.30 inches. Based on the 5.875 inch measurement of the I-Beam, the Rail Feeder Chute is seen to be approximately  $(1.04/1.30) * 5.875 = 4.70$  inches wide.

15. Based on these measurements, I believe that TRINITY012683 shows a 5-inch version of the Rail Feeder on the ET-PLUS, and not a 4-inch version.

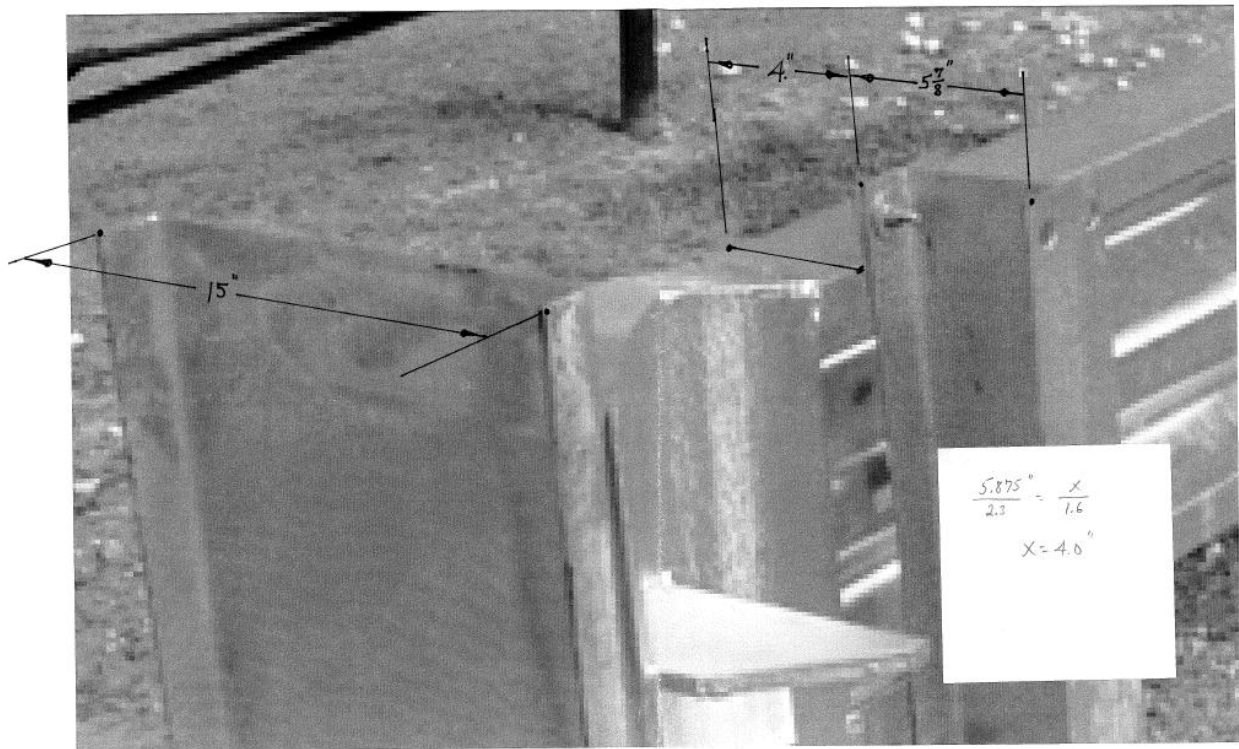
16. The photograph for TRINITY 012683 is shown below:

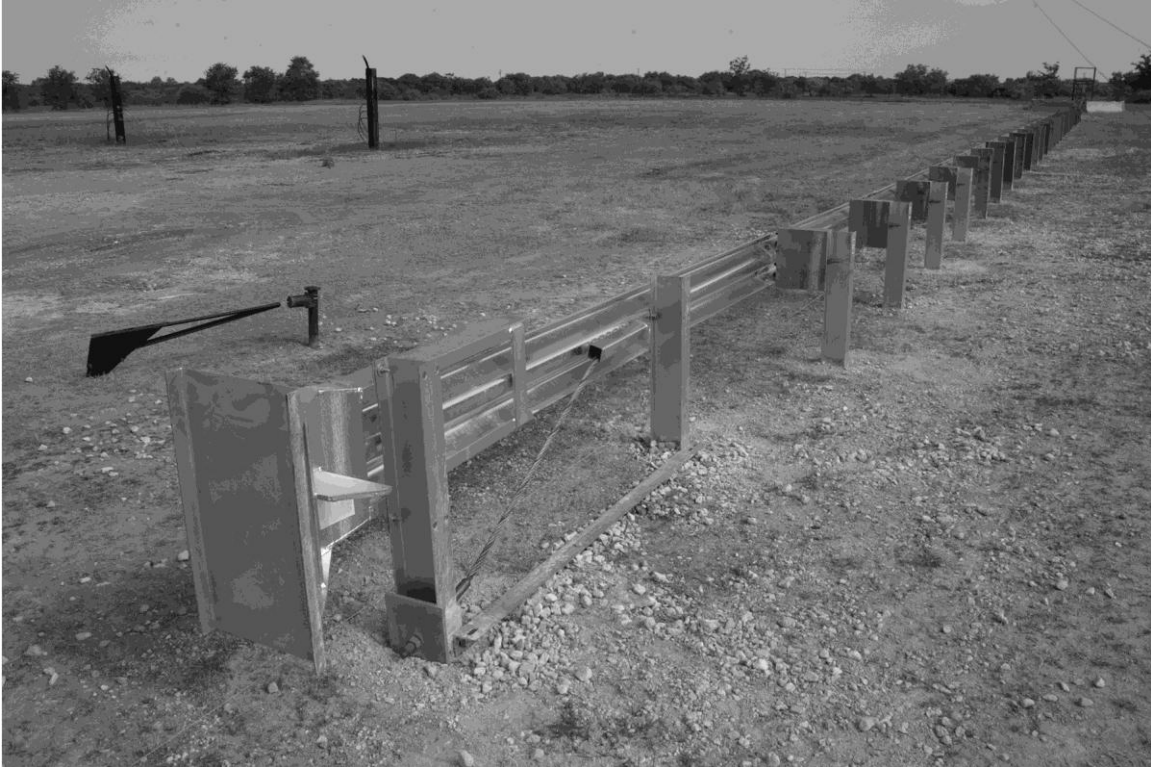
17. The photograph of TAMUS007835 is shown below:

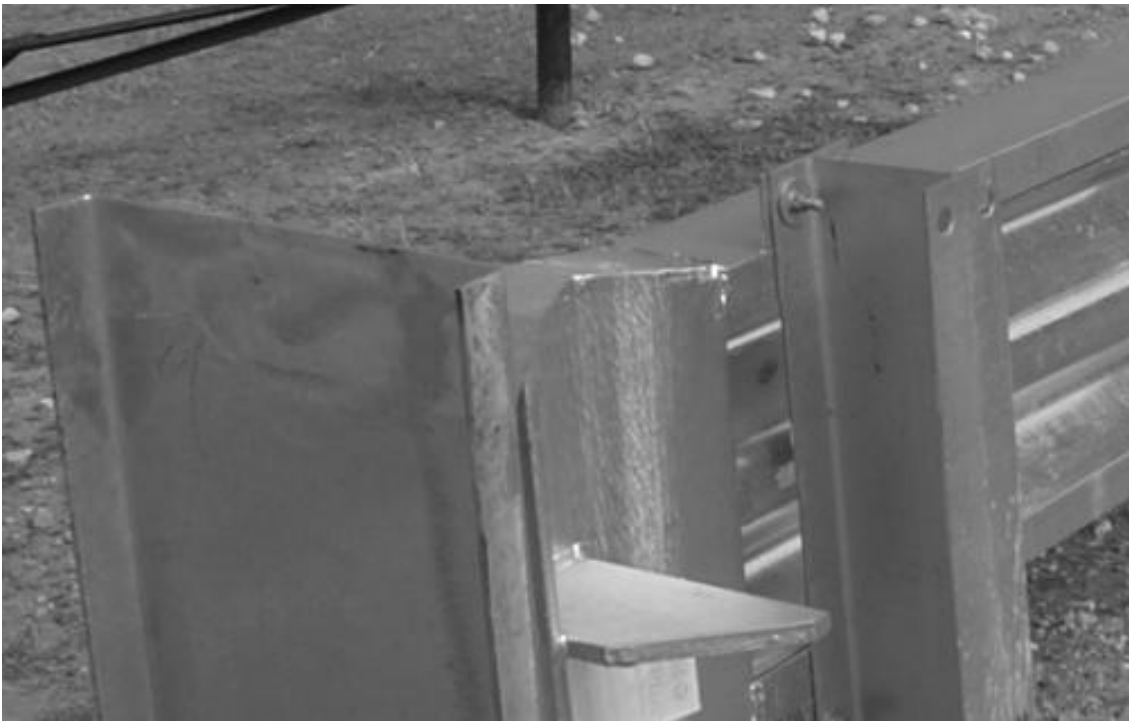
18. The following shows TAMUS007835 cropped similar to TRINITY012683:

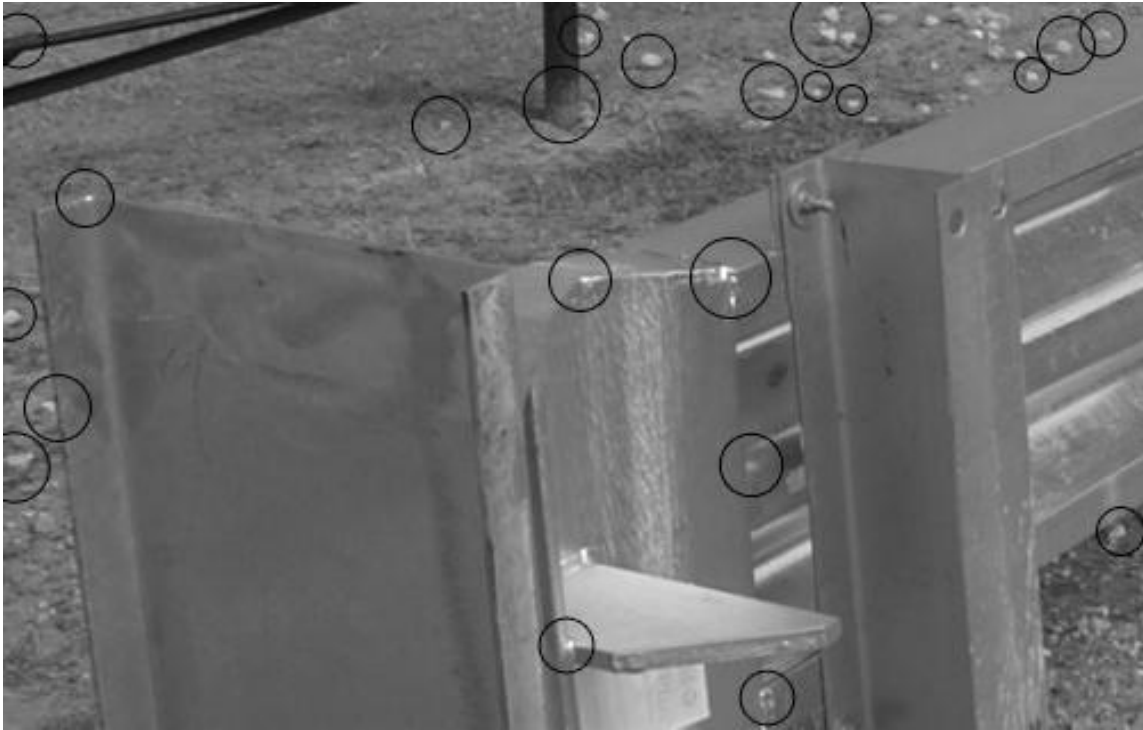
19. Note the following identification marks that are the same for both photographs:

20. Therefore, in my opinion, the photograph used for TRINITY012683 is a cropped section of TAMUS007835

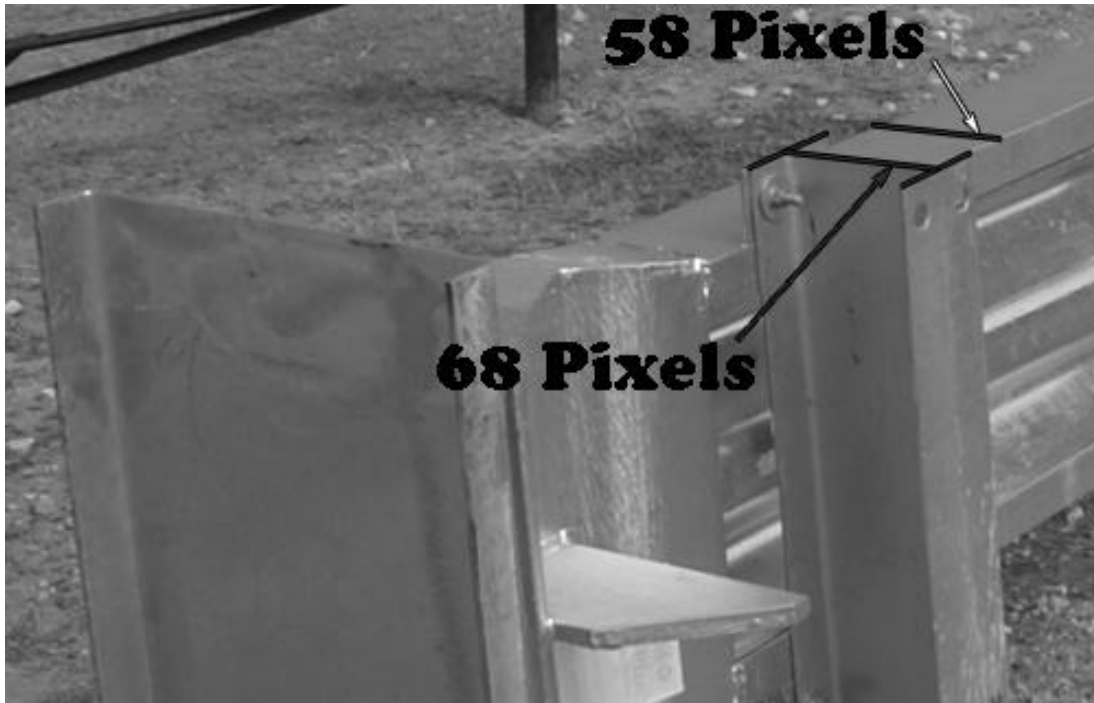
22. As shown, I carefully measured the width of the I-Beam in the figure below, and found it to be approximately 68 pixels. I also carefully measured the width of the Rail Feeder portion of the ET-PLUS, using a parallel line. I measure the width as 58 pixels.

23. Based on the 5.875 inch measurement of the I-Beam, the Rail Feeder Chute is seen to be approximately  $(58/68) * 5.875 = 5.01$  inches.

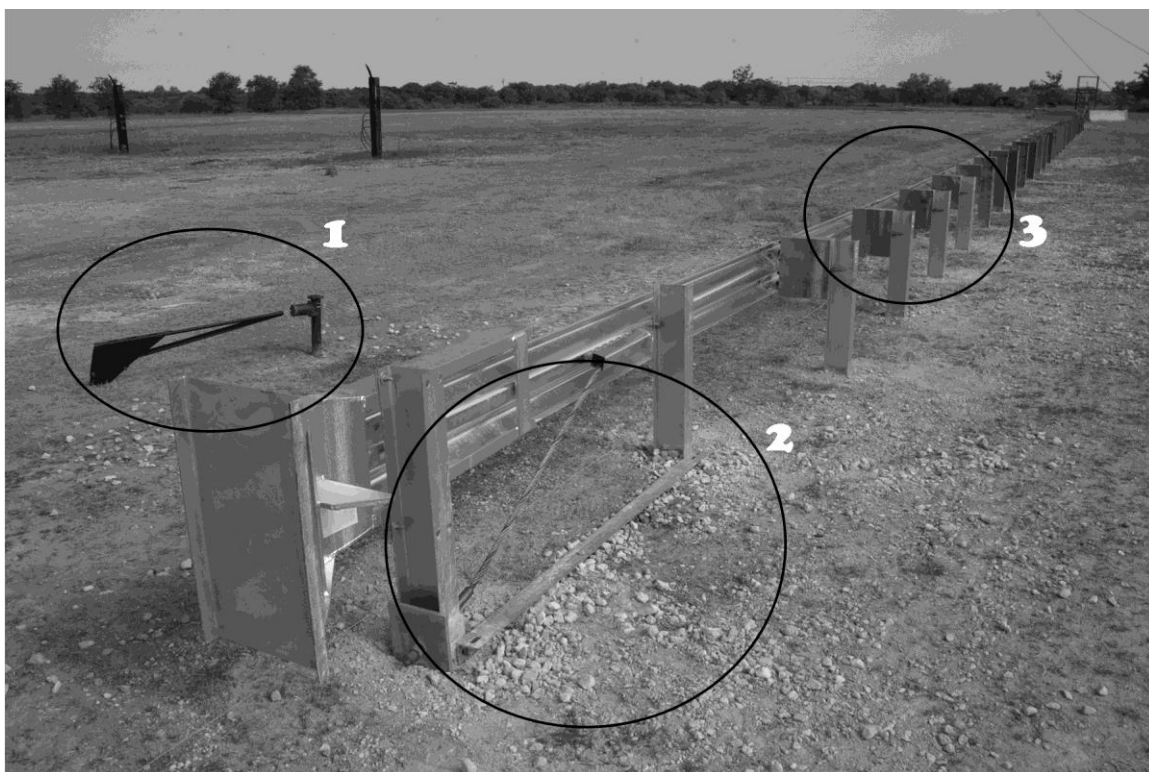
24. There are three area of photograph TAMUS007835 that positively identify it as a section of the rail from the 3-35 Pickup Truck Test (see the photograph below):
- a. The Stake and Guide cable (Area 1)
  - b. The Angle Iron (Area 2)
  - c. The Support Post Numbering (Area 3)

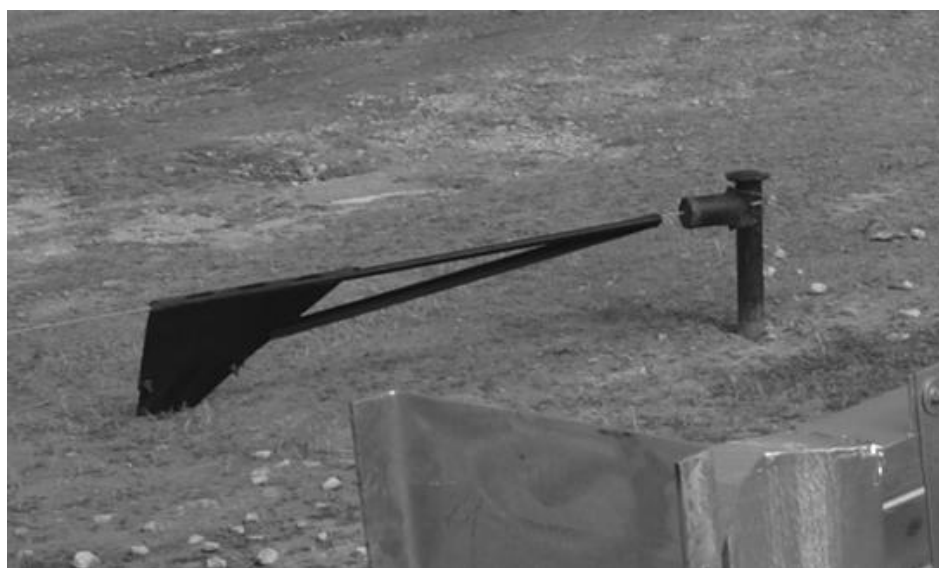
25. Photograph TAMUS007835 contains a stake and guide cables to guide the Pickup Truck into the guard rail at the proper point. This is shown enlarged below:

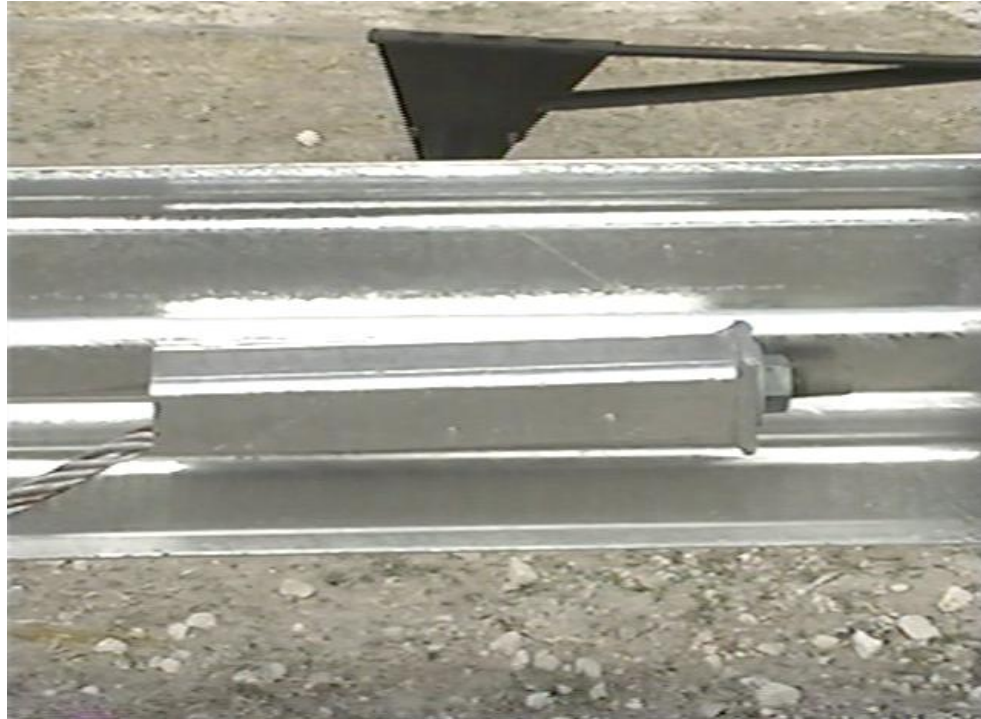
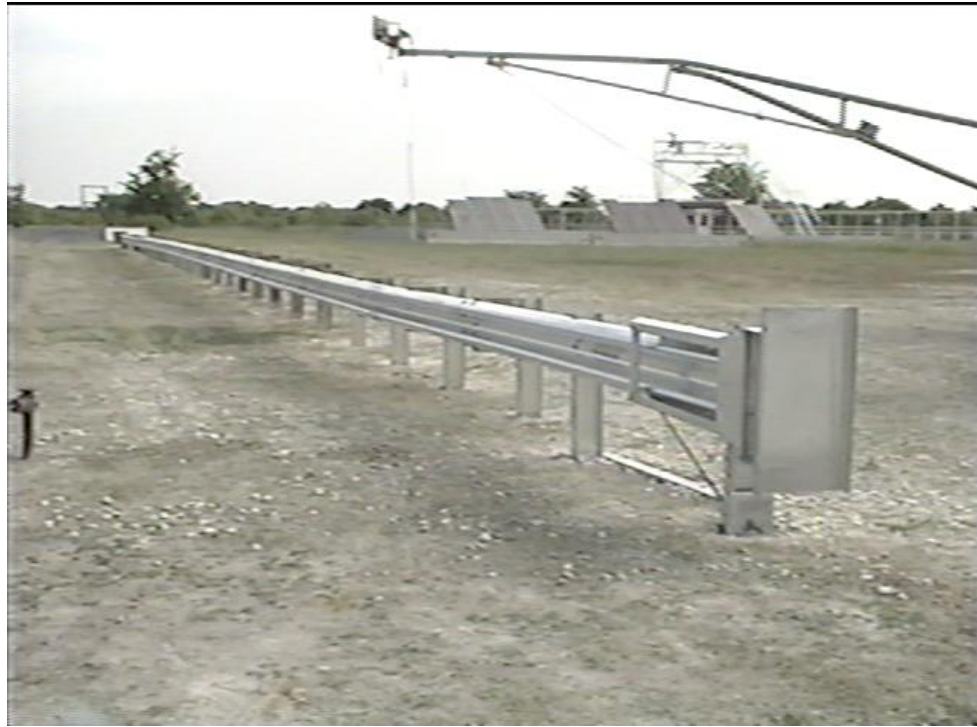
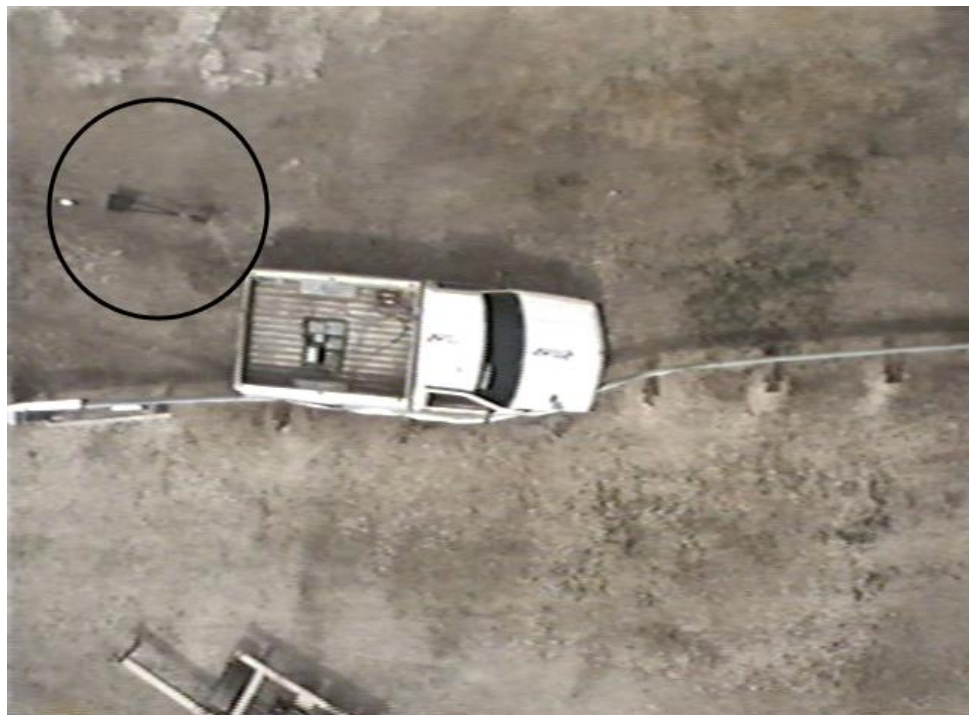
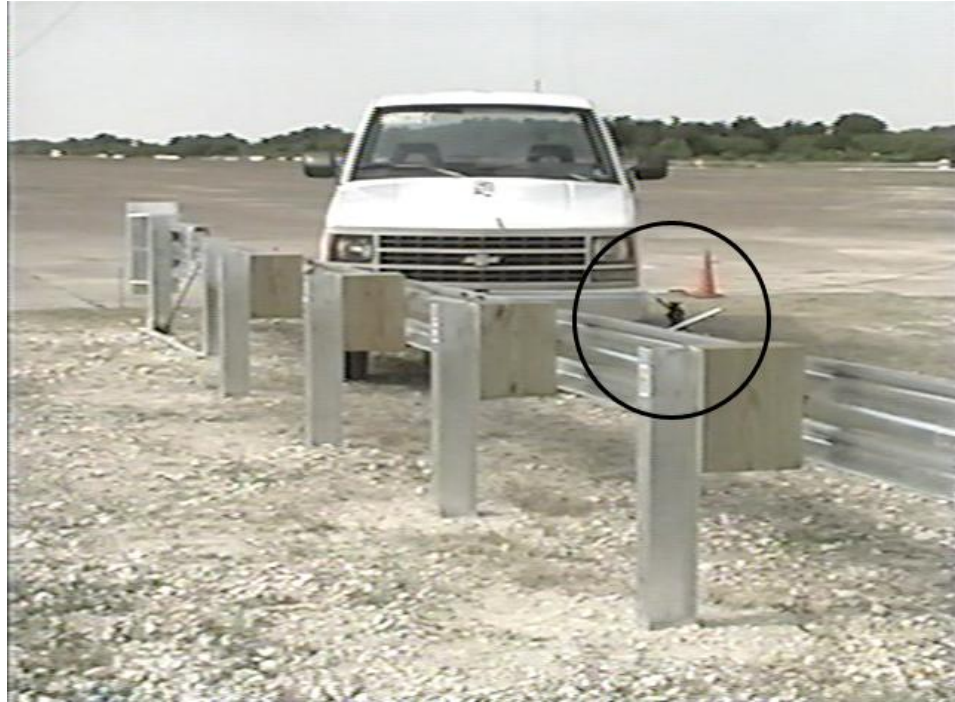
26. This stake and guide cables are present in the Pickup Truck Test. See the following four screen captures from 2:47, 1:13, 4:26 and 0:34 of the video, respectively. In all cases, the stake and/or cable can be clearly seen.

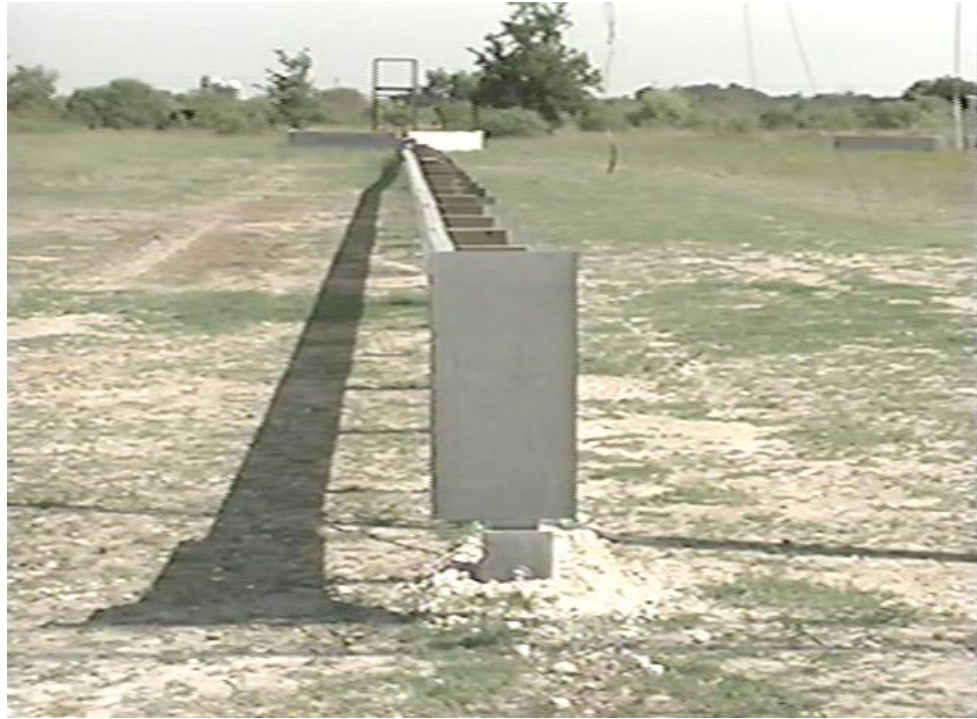
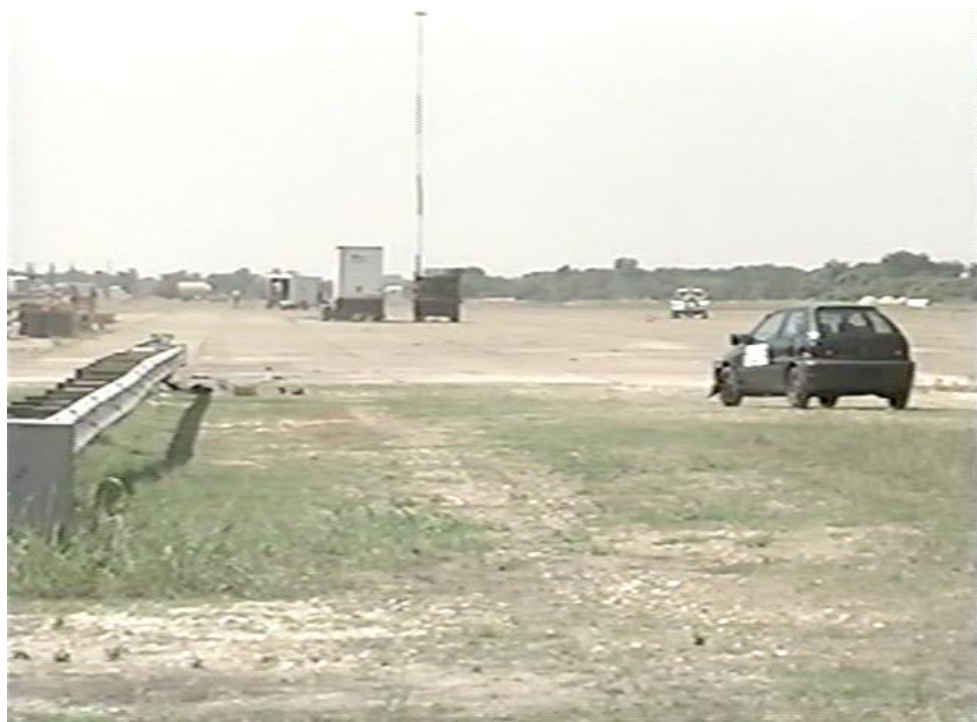
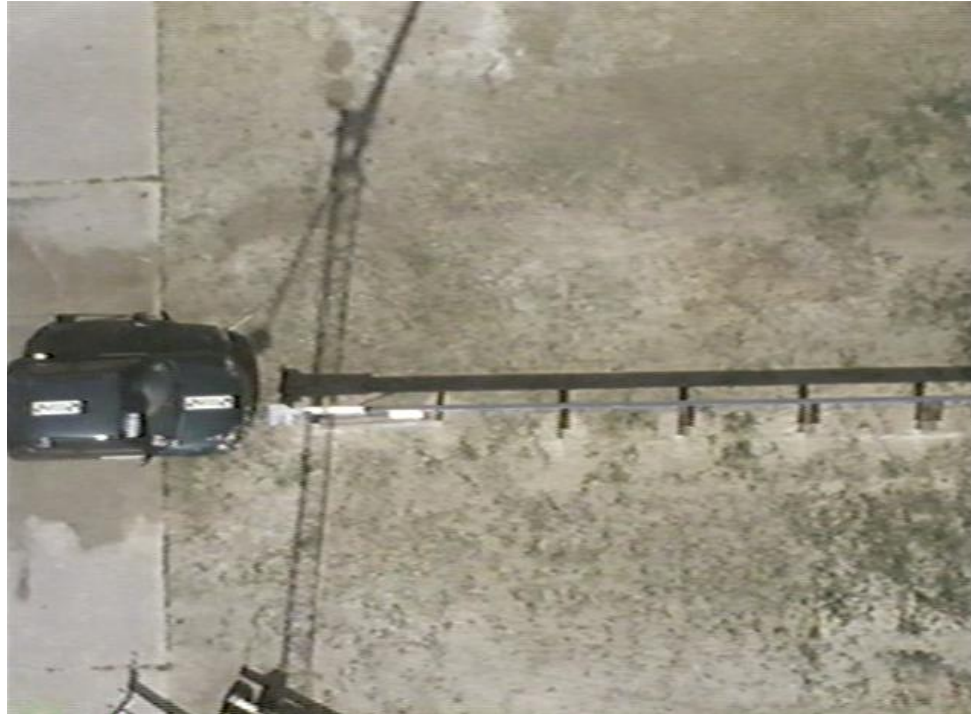
27. This stake and guide cables set up in a completely different manner in the Small Car Test, since it is an axial test. See the following three screen captures from 1:42, 5:14 and 5:35 of the video, respectively. In all three cases, the stake and cable are clearly absent from the location as shown in TAMU007835

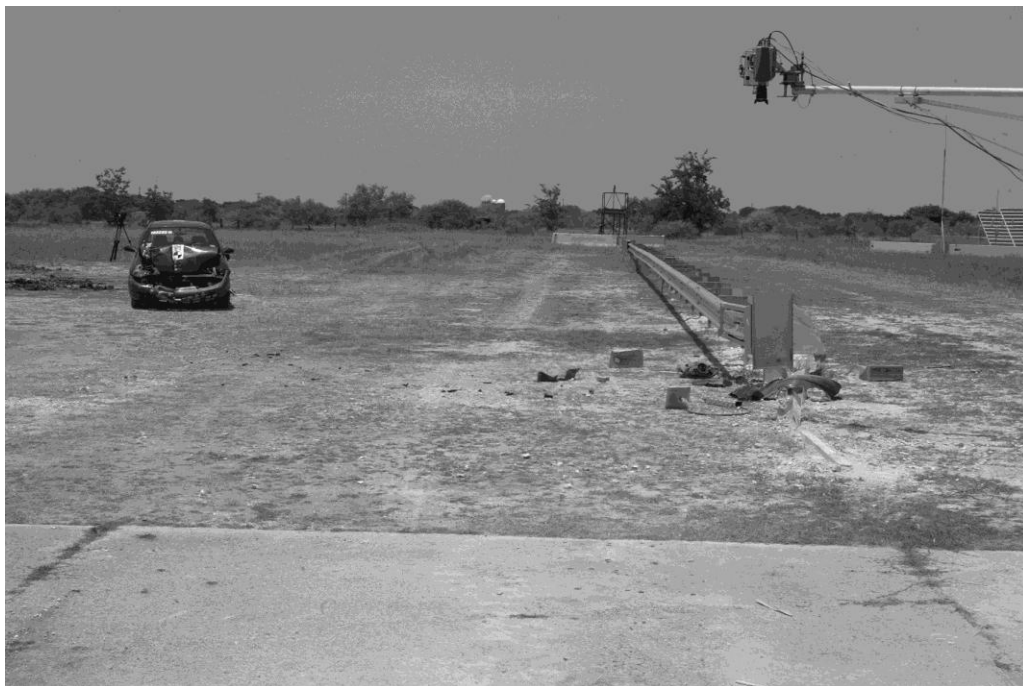
28. Finally, TAMSU007883, a photograph of the results of the Small Car Test, also does not show the stake and cable guides:

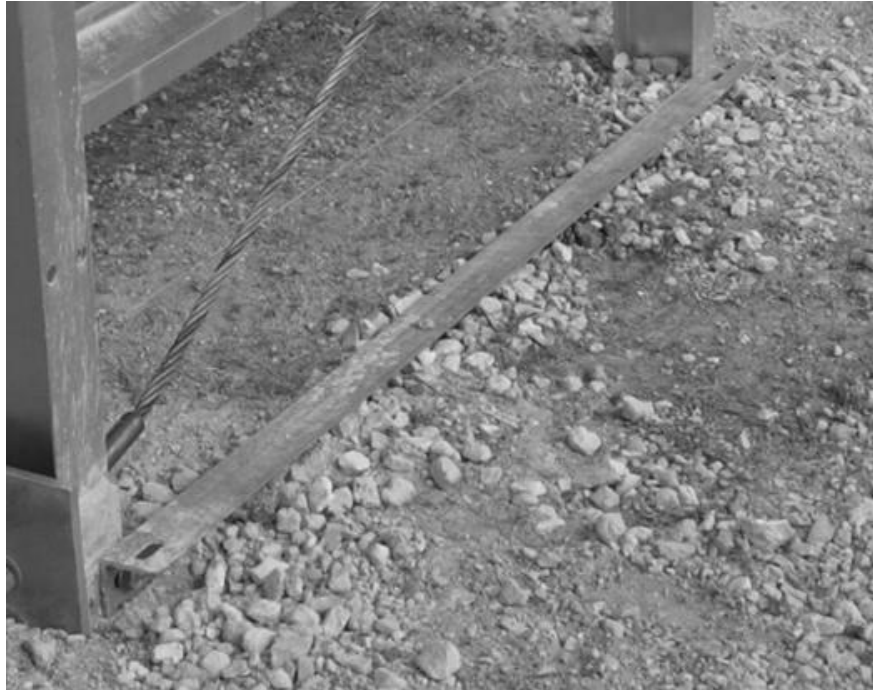
29. Photograph TAMUS007835 contains an angle iron, which is slightly above the ground (especially near support post 1, in the lower left hand corner of the photo). See the enlarged photo below:

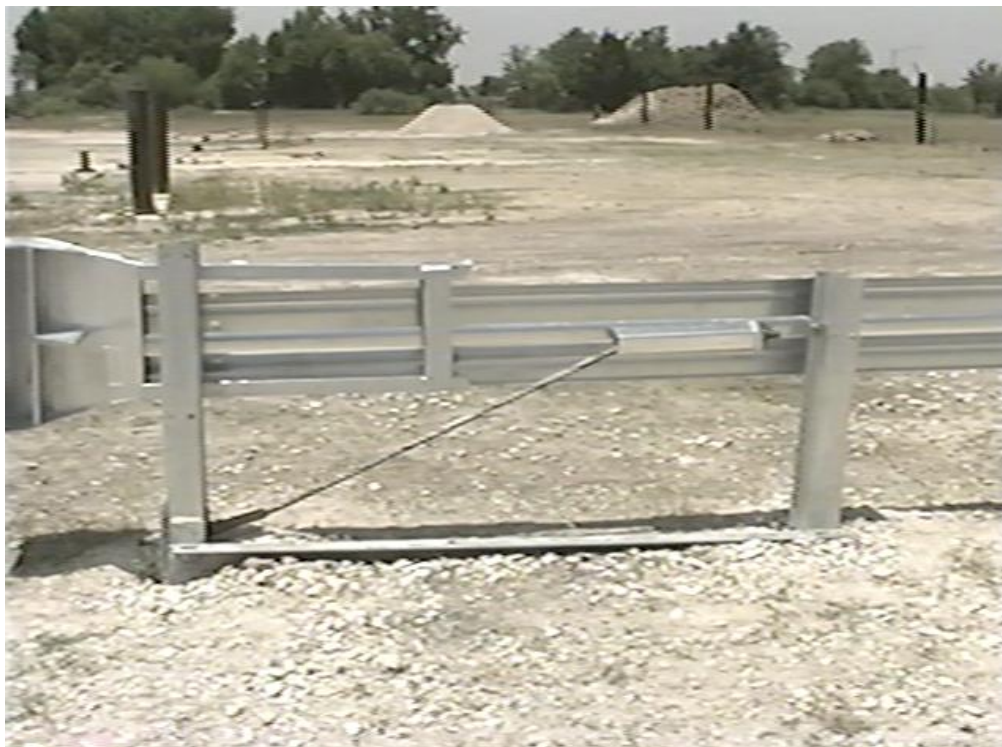
30. This slightly-above-ground angle iron is present in the Pickup Truck Test. See the following screen capture from 7:03 of the Pickup Truck Test video. In this case, the slightly-above-ground angle iron (near the first support post) can be clearly seen.

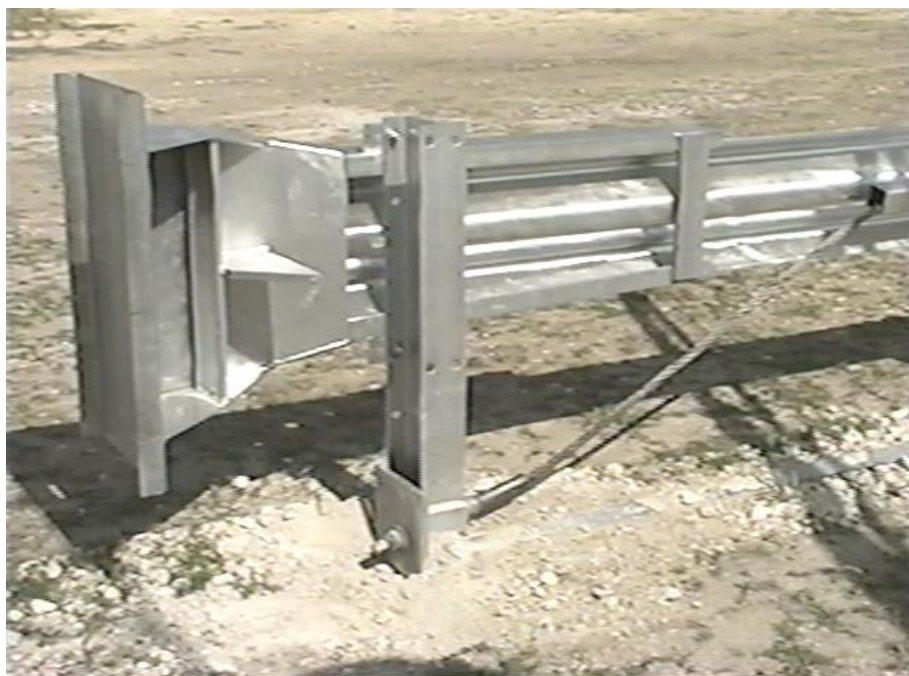
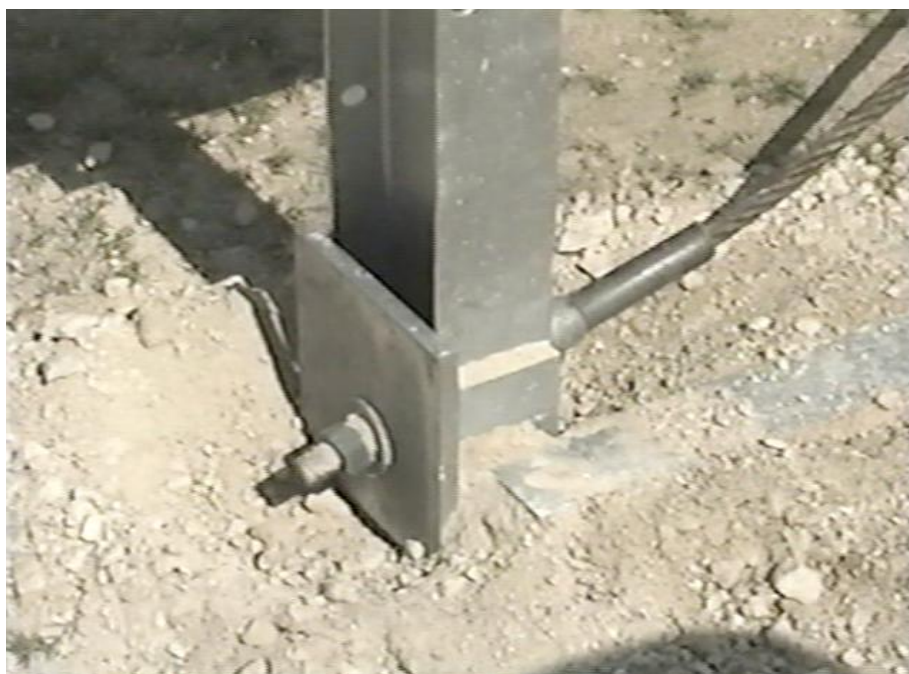
31. In the Small Car Test, the angle iron is buried in the ground to a much greater extent. See, for example, the following screen capture from 2:19 and 2:28 of the video, respectively. As can be seen, there is no slightly-above-ground angle iron; instead, the angle iron appears to be fully buried in the ground.

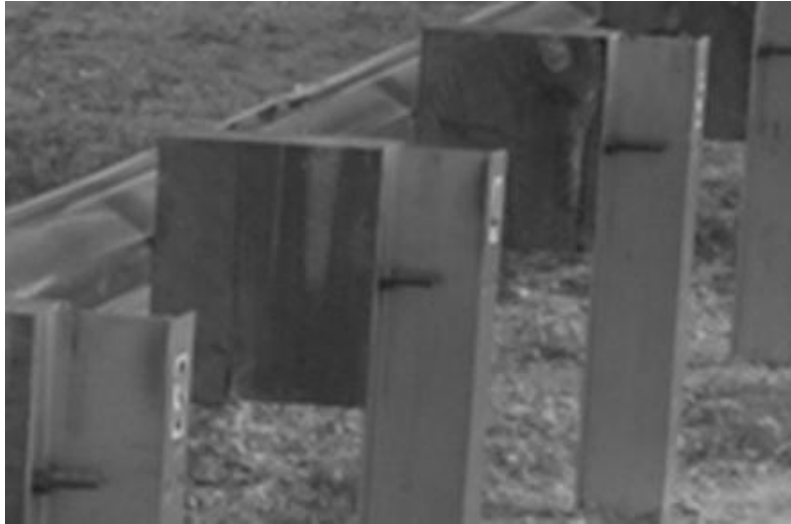
32. Photograph TAMUS007835 contains Black-Letters-on-White Decals marking the Support Post numbers. See the follow enlarge section of TAMUS007835:

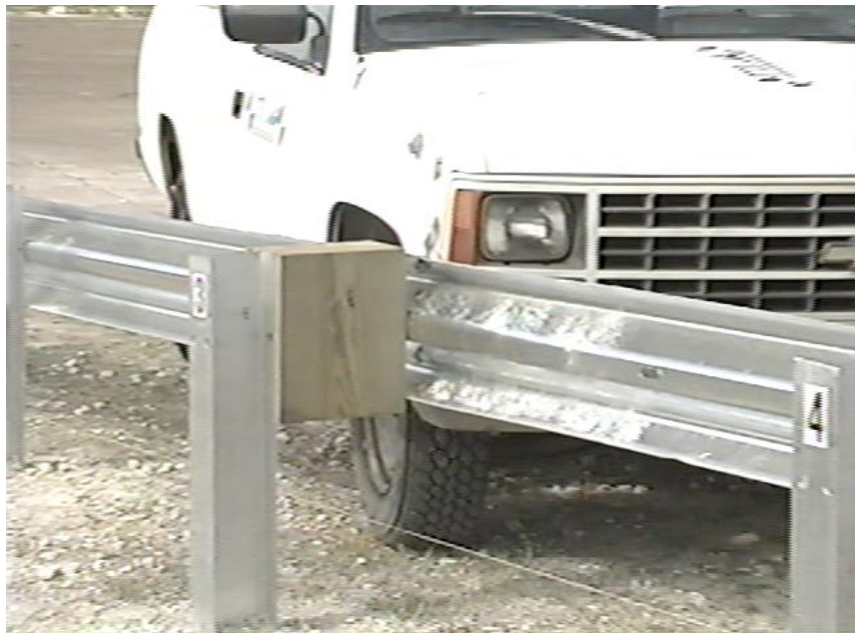
33. In the video for the Pickup Truck Test, the Black-Letters-on-White Decals can be seen. For example, see the following screen capture at 0:45 of the Pickup Truck Test Video:

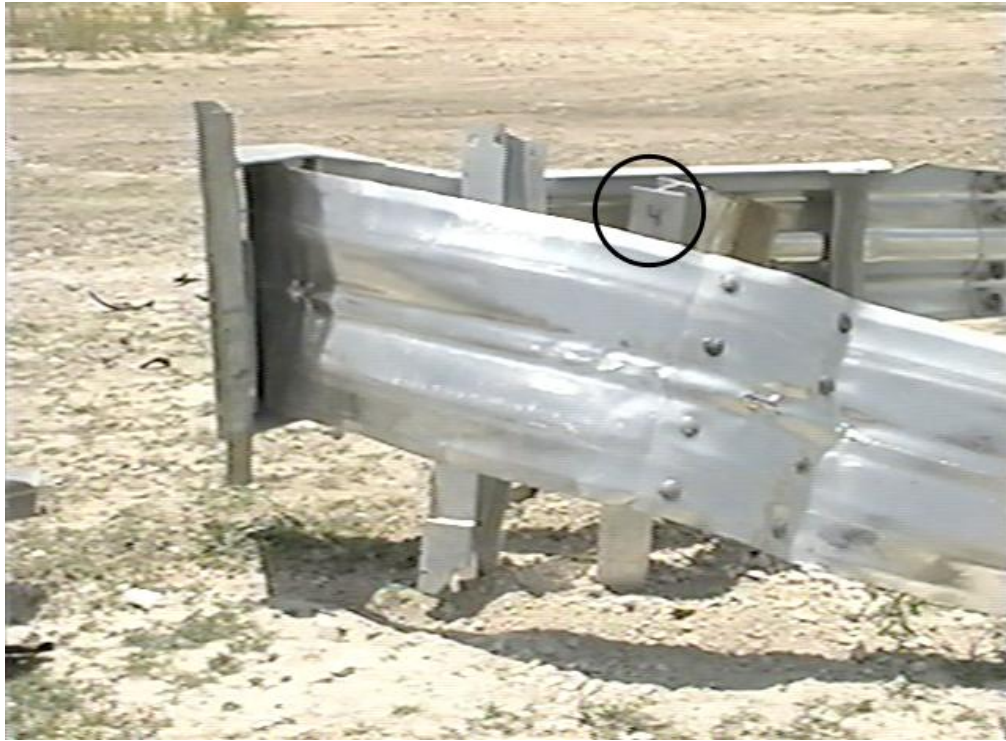
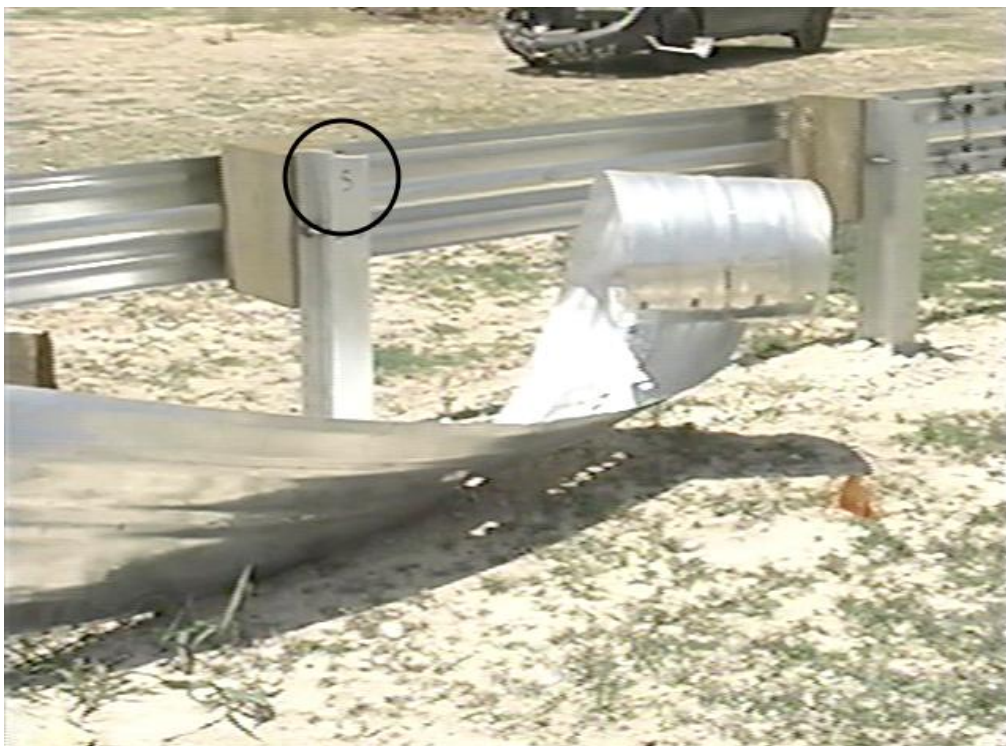
34. In the video for the Small Car Test, the Support Posts are numbered quite differently. It appears to be a hand lettering using a black marker. And there is

clearly no white background. See the following video captures from 8:42 and 8:51 of the Small Car Test video:
