1. Report No.	2. Government Accession No.	3. Recipient's Catalog No.	
4. Title and Subtitle NCHRP REPORT 350 TESTING OF THE ET-PLUS FOR 31-INCH-HIGH W-BEAM GUARDRAIL		5. Report Date July 2005	6. Performing Organization Code

7. Author(s) C. Eugene Buth, Dean C. Alberson, Roger P. Bligh, and D. Lance Bullard, Jr.		8. Performing Organization Report No. 220601-1&2	
9. Performing Organization Name and Address Texas Transportation Institute The Texas A&M University System College Station, Texas 77843-3135		10. Work Unit No. (TRAIS)	11. Contract or Grant No. 220601

12. Sponsoring Agency Name and Address Trinity Industries, Inc. 2525 Stemmons Freeway Dallas, TX 75207		13. Type of Report and Period Covered Test Report: April 2005 – June 2005

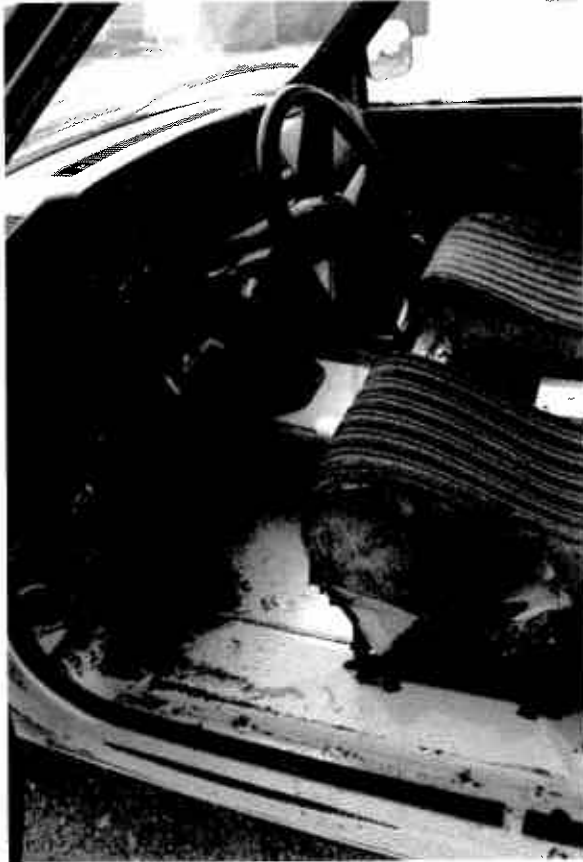
Figure 14. Interior of vehicle for test 220601-1.

The vehicle sustained damage to the right side, as shown in figure 13. Structural damage included a broken right outer tie rod end and deformed right frame rail. Other damage included the front bumper, hood, grill, radiator, fan, right front quarter panel, right door, right rear exterior bed, and the rear bumper. Both wheel rims on the right side were deformed and the tires deflated. Maximum exterior crush to the vehicle was 530 mm in the right side plane at the right front corner at bumper height. No measurable occupant compartment deformation occurred. Photographs of the interior of the vehicle are shown in figure 14. Exterior vehicle crush and occupant compartment measurements are shown in appendix B, tables 3 and 4.

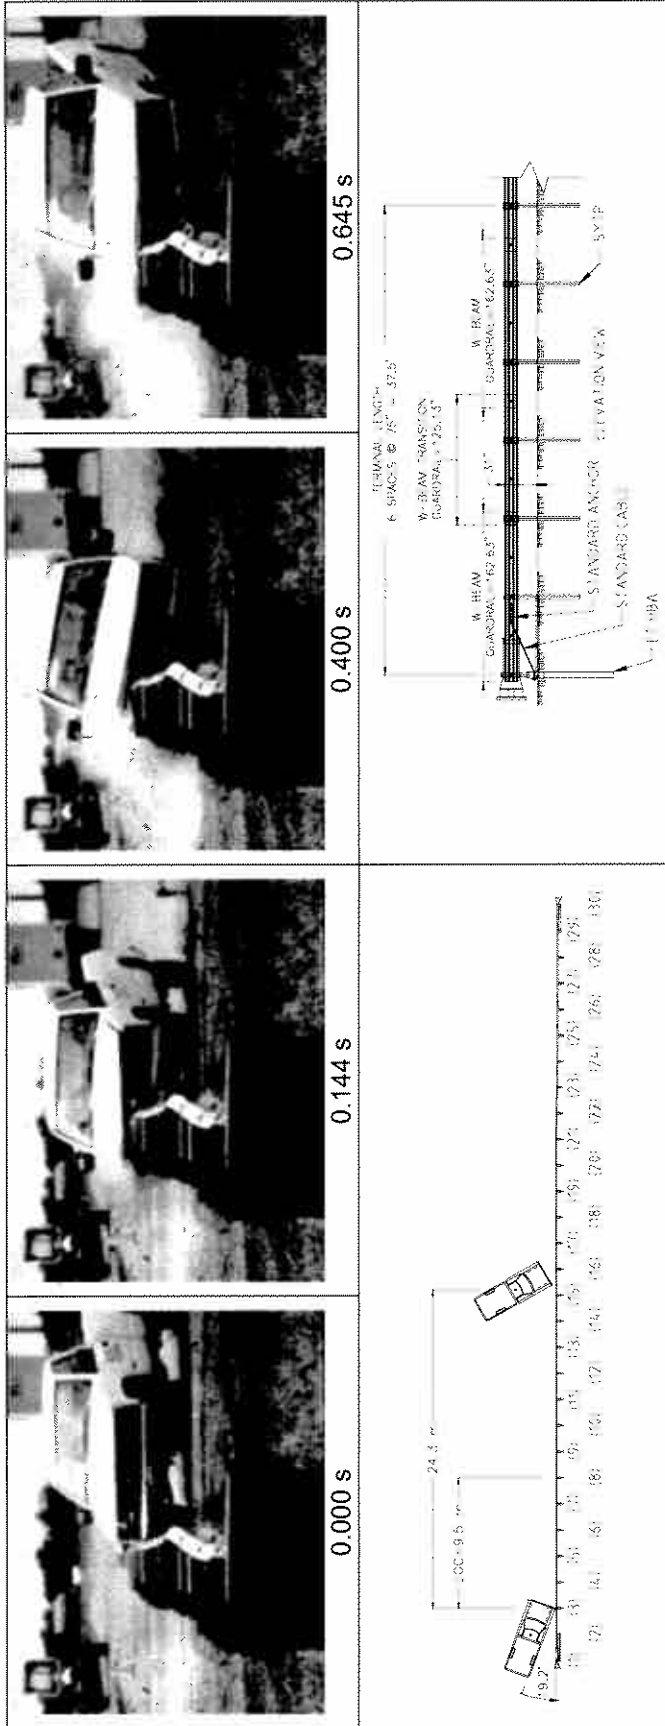
The ET-PLUS for 787 mm (31-inch) high W-beam guardrail contained and redirected the pickup truck with a maximum dynamic rail deflection of 939 mm. One breakout split, and a portion separated from post 6 and came to rest next to post 7. However, the split breakout did not penetrate nor show potential for penetrating the occupant compartment, nor to present undue hazard to others in the area. No measurable occupant compartment deformation occurred. The pickup truck remained upright during and after the collision event. The pickup truck did not intrude into adjacent traffic lanes. As the vehicle lost contact with the rail, it yawed clockwise and came to rest adjacent to the rail. Occupant risk factors were within the required limits. Exit angle at loss of contact was not attainable; however, the vehicle was yawing clockwise (toward the rail) as it lost contact.

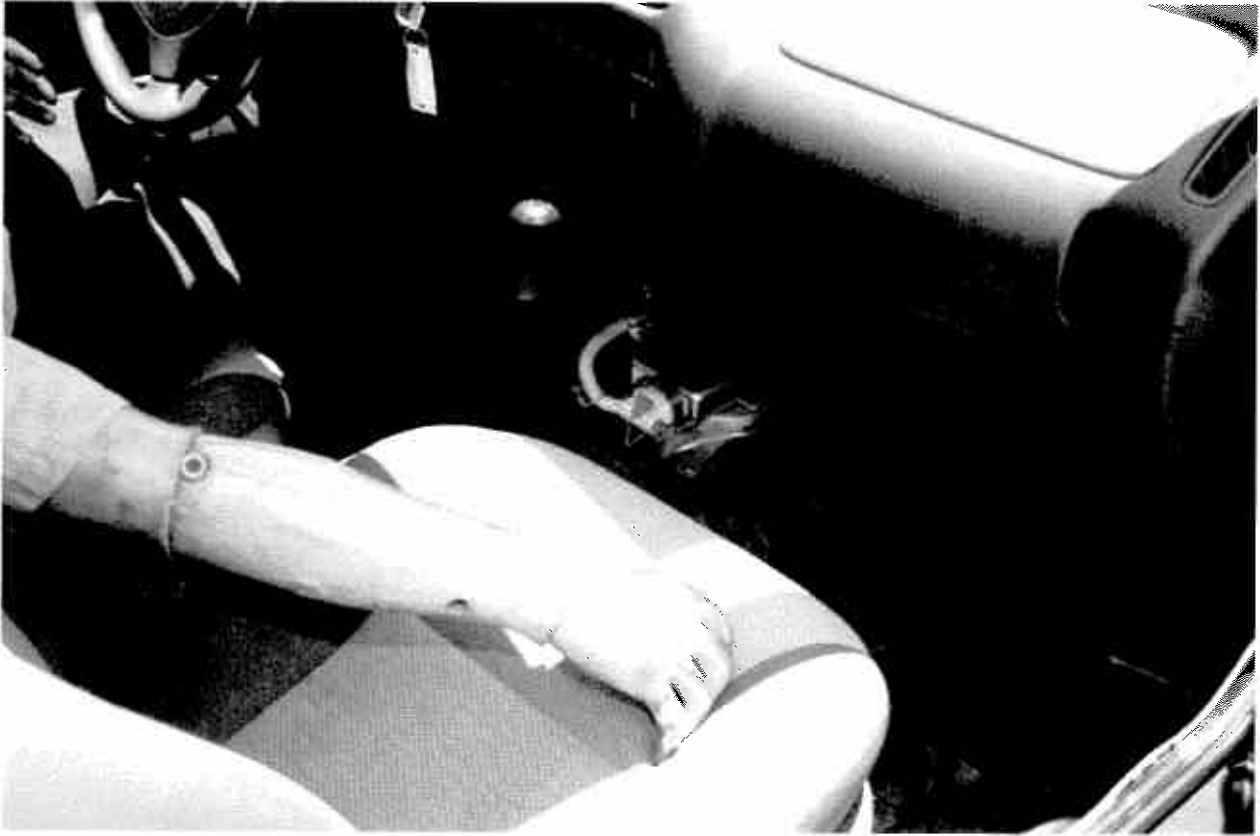
Figure 21. Interior of vehicle for test 220601-2.

The vehicle sustained damage to the front, as shown in figure 20. The only structural damage was a deformed right strut tower. Other damage included deformation of the front bumper, hood, radiator, fan, radiator support, and right and left front quarter panels. The right rear tire was deflated. Maximum exterior crush to the vehicle was 420 mm in the frontal plane at the front right corner just above the bumper. No occupant compartment deformation occurred. Photographs of the interior of the vehicle are shown in figure 21. Exterior vehicle crush and occupant compartment measurements are shown in appendix B, tables 5 and 6.

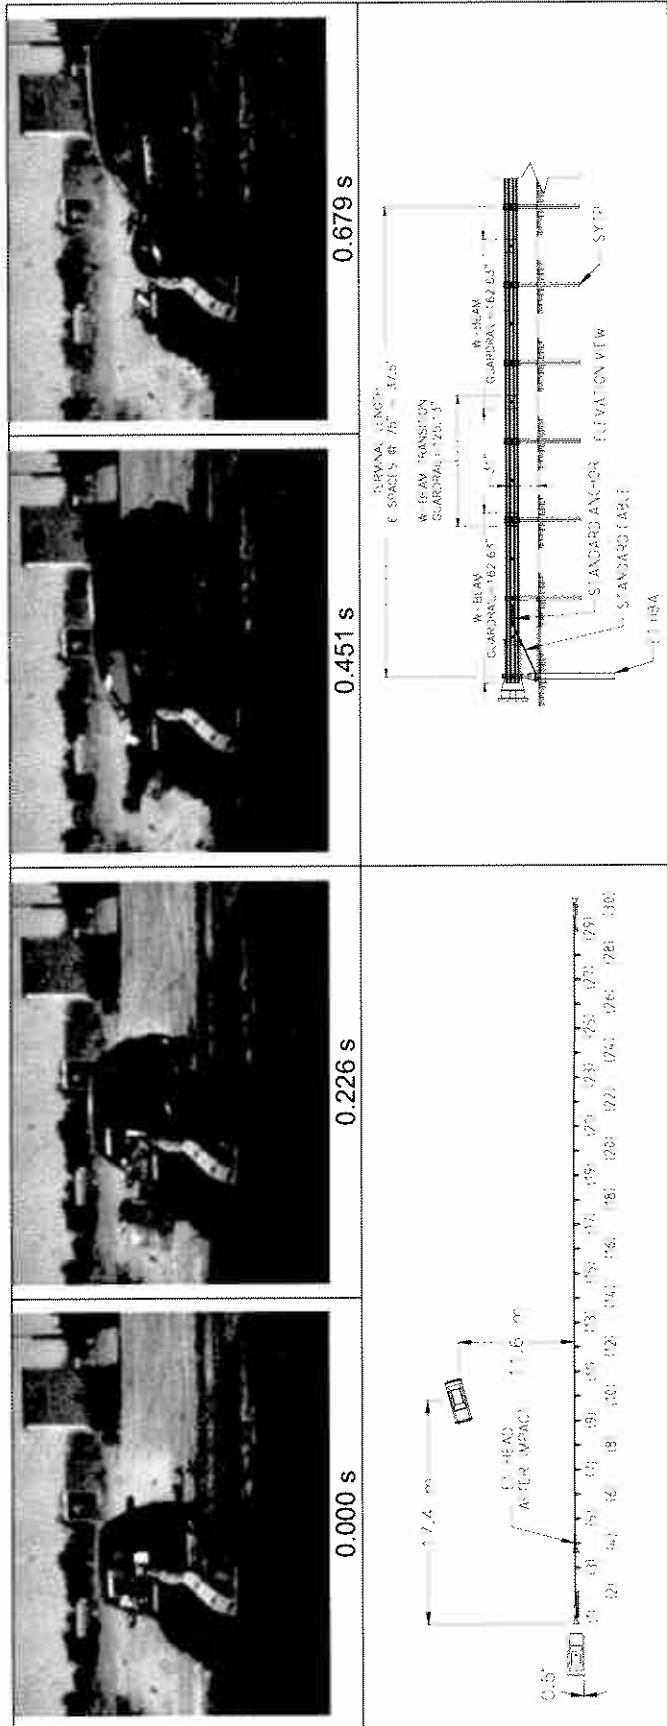
Result: The small car intruded into traffic lanes 8.5 m. (FAIL)

The small car was brought to a controlled stop on the traffic side of the installation. Post 1 and the anchor assembly separated from the installation; however, neither of these penetrated nor showed potential to penetrate the occupant compartment, nor to present any hazard to others in the area. No occupant compartment deformation occurred. The small car remained upright during and after the collision event. Occupant risk factors were within the specified limits. The small car intruded 8.5 m into traffic lanes as it came to rest on the traffic side of the rail.

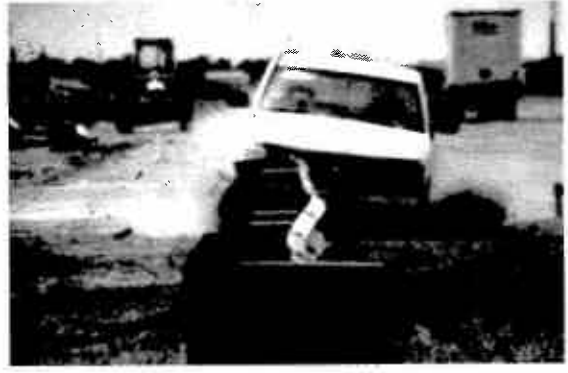
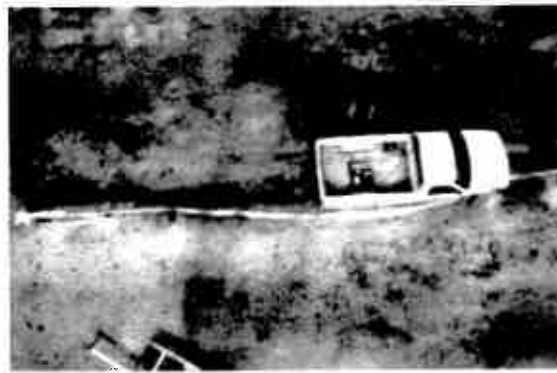
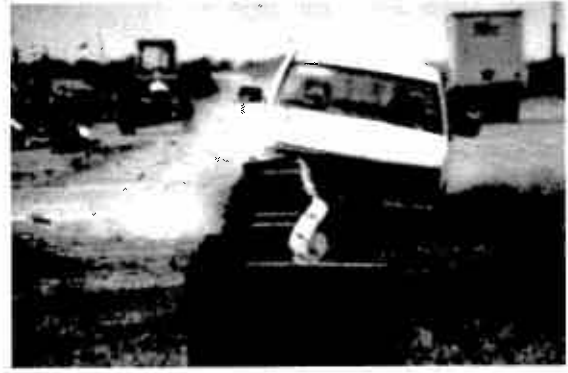
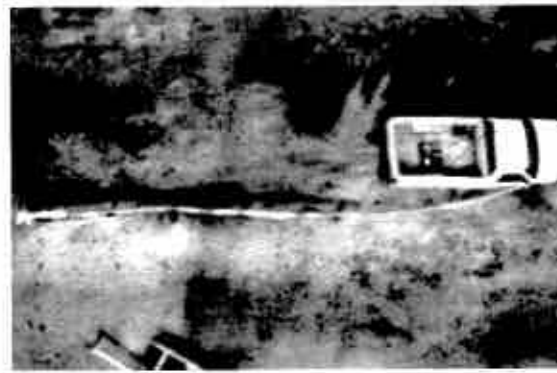
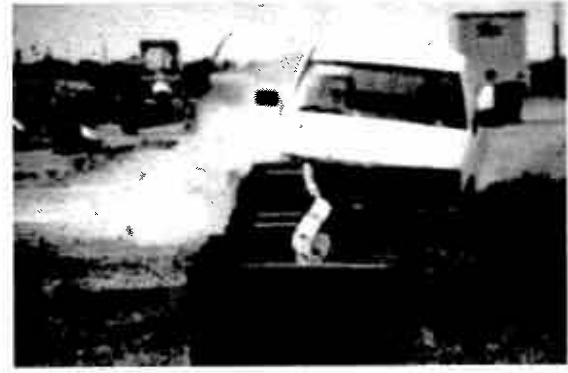
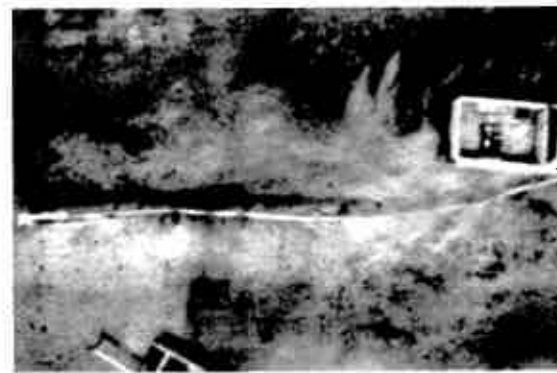
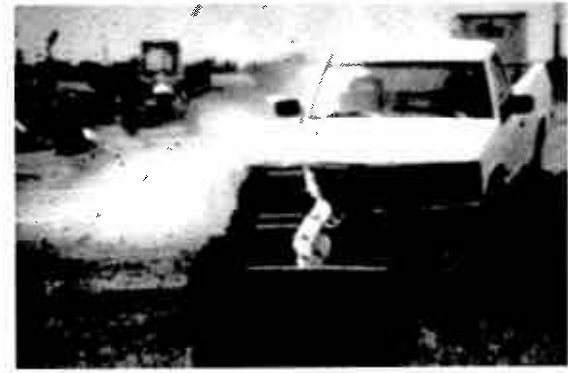
Figure 25. Sequential photographs for test 220601-1 (overhead and frontal views) (continued).

The pickup truck, traveling at an impact speed of 100.5 km/h, impacted the ET-PLUS for 787 mm (31-inch) high W-beam guardrail at post 3 at an impact angle of 19.2 degrees. At approximately 0.044 s after impact, the vehicle began to redirect. The front of the vehicle reached post 4 at 0.068 s, and the tire/wheel assembly contacted the post at the base at 0.079 s. At 0.144 s, the front of the vehicle reached post 5, and at 0.160 s, the tire contacted post 5 and rode over it. The vehicle reached post 6 at 0.222 s, and the tire contacted post 6 at 0.246 s and rode over the post. At 0.305 s, the vehicle reached post 7, and at 0.344 s, the tire contacted post 7 and rode over the post. The vehicle reached post 8 at 0.400 s, and post 9 at 0.523 s, at which time the vehicle began to yaw clockwise. The vehicle continued out of view of the overhead camera while still in contact with the rail. At 0.791 s, the vehicle lost contact with the rail, and at 1.668 s, the vehicle contacted the rail a second time at post 15, and came to rest between posts 15 and 16. Sequential photographs of the test period are shown in appendix C, figures 25 and 26.

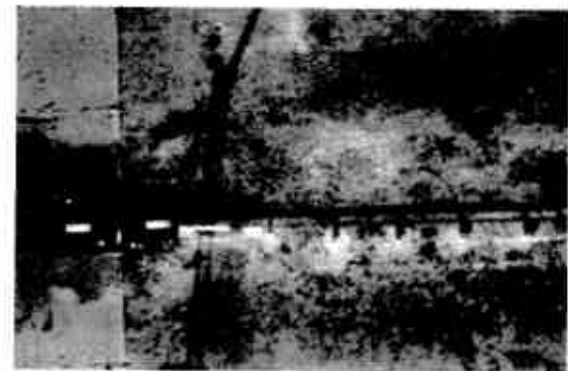
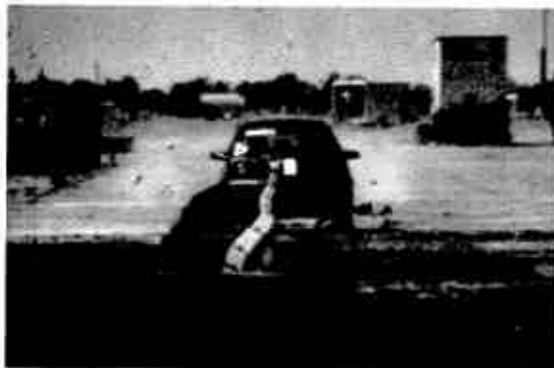
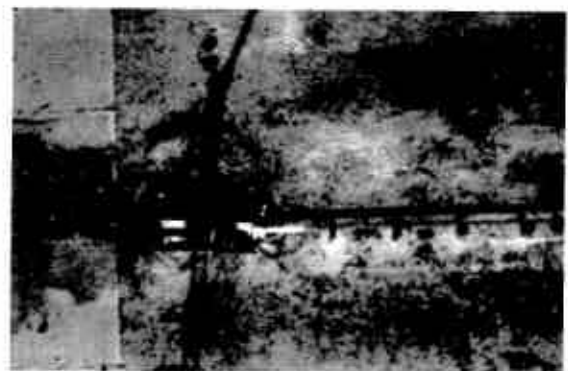
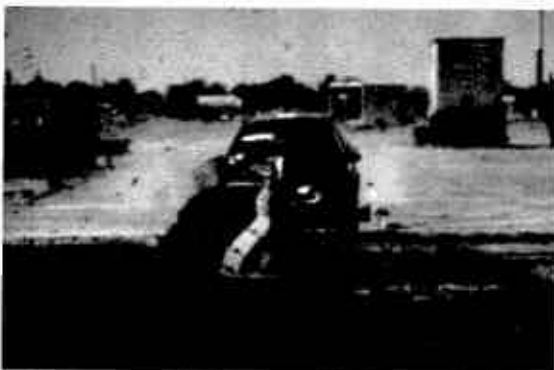
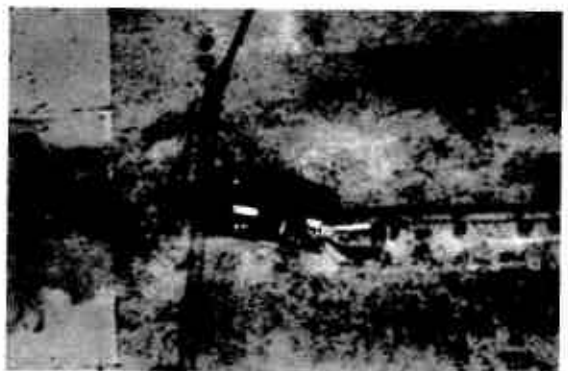
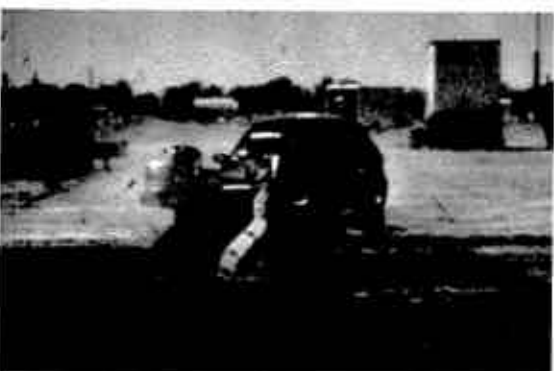
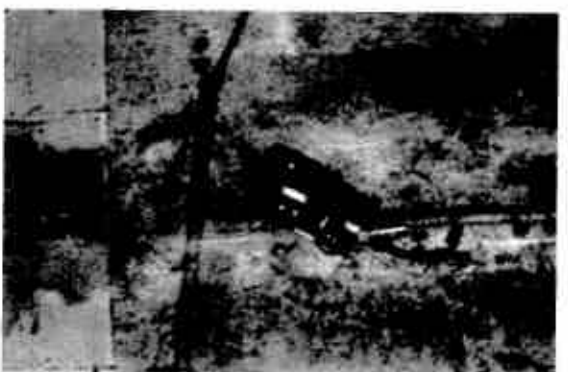
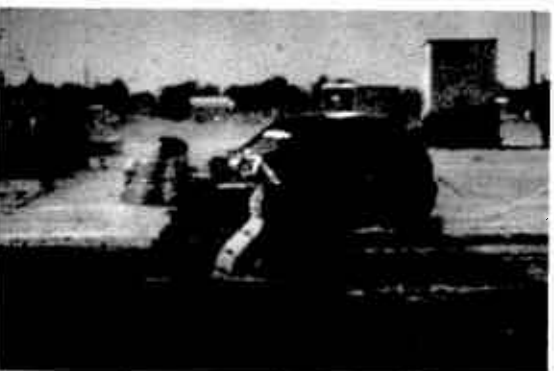
Figure 27. Sequential photographs for test 220601-2 (overhead and frontal views).

The small car, traveling at a speed of 101.8 km/h, impacted the end of the ET-PLUS for 787 mm (31-inch) high W-beam guardrail at an impact angle of 0.5 degrees with a quarter-point offset toward the traffic side of the rail. Upon contact with the head, the guardrail began to feed through the chute, and by 0.032 s, the front of the vehicle reached post 1. The vehicle began to yaw clockwise at 0.052 s. At 0.061 s, the end of the chute reached post 2, and at 0.118 s, the front of the vehicle reached post 2. The end of the chute reached post 3 at 0.152 s, and the front of the vehicle reached post 3 at 0.221 s. At 0.270 s, the end of the chute reached post 4, and at 0.387 s, the front of the vehicle reached post 4. The vehicle was at 90 degrees to the rail at 0.608 s, and was traveling sideways when it lost contact with the rail at 0.679 s. The small car came to rest 17.4 m downstream of impact and 8.5 m in front of the traffic face of the rail. Sequential photographs of the test period are shown in appendix C, figures 27 and 28.
